Errors of distraction

When mechanics get interrupted, bad things can happen

BY MIKE BUSCH

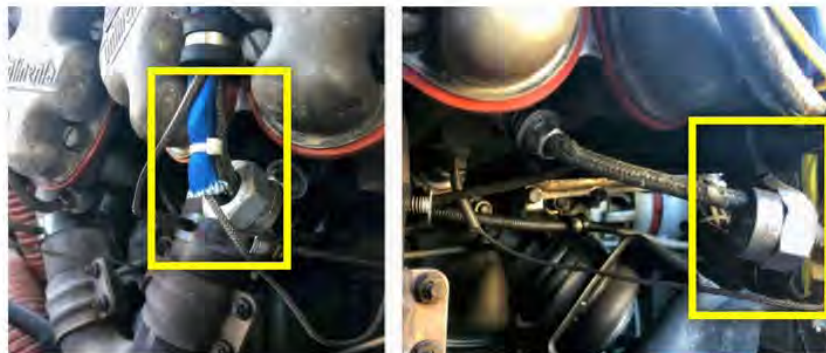
THE IGNITION LEAD B-NUTS on two spark plugs had backed off, and the ones on the other 10 plugs were loose.

Sam removed the top engine cowling and was horrified to find that the ignition leads on two cylinders had B-nuts that were floating free and cigarettes (insulators) that were partially backed out from the spark plugs. He hand-checked the B-nuts on the ignition leads for the other four cylinders and found all of them to be loose and in the process of backing off the plugs.

A week later, Rick met Sam at the airplane to rectify the problem with the loose ignition harness B-nuts. Sam brought the other discrepancies he’d found to Rick’s attention and asked him to correct these issues as well. Sam gave Rick keys to the airplane and asked to be notified when the work was finished. The next day, Rick advised Sam that the airplane was “good to go” and that he would “have no problem flying it with his kids on board.”

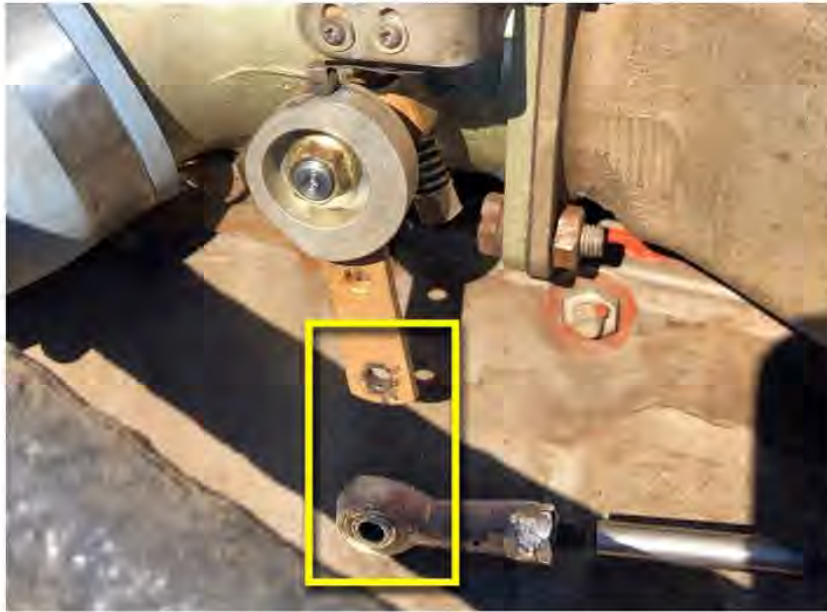
THE THROTTLE CABLE was found disconnected from the throttle bellcrank, and the attaching hardware was gone.

Upon entering the traffic pattern, they throttled back further, but the engine did not respond to the throttle inputs, and manifold pressure remained at 21 inches. Attempts to move the throttle in either direction now had no effect on engine power. Sam’s pilot friend took control and reduced power by pulling the mixture control and was able to land without incident.

After landing, Sam removed the top cowling and observed that the throttle cable rod end was not connected to the bellcrank on the throttle body. The clevis bolt and its retaining nut and cotter pin were missing and could not be located. Understandably, Sam’s faith in his airplane and mechanic were badly shaken. Sam and his friend were not injured, and the aircraft was undamaged. They were fortunate. Literally the day before Sam told me his story, I had been reading an NTSB probable cause report of a fatal accident that was eerily similar.
