P&E | SAVVY MAINTENANCE

I wanna sue!

**When things go awry in the sky,
litigation isn't necessarily the best remedy**

BY MIKE BUSCH

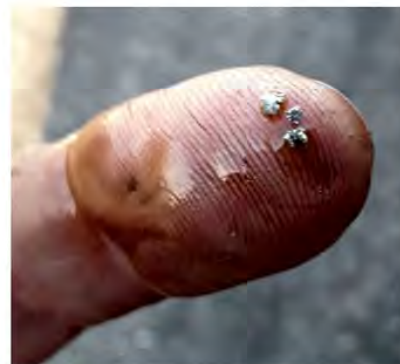
THESE TINY PIECES OF METAL chipped off the crankshaft cluster gear were responsible for the Liberty XL2 owner's expensive saga.

A few hours later, the owner called me back to say he'd talked to the engine shop. The bottom end of the engine was indeed found to be undamaged, just as I'd predicted. Beyond the damaged cluster gear, the only damage found by the engine shop was some scoring of the oil pump housing plus some scoring of the pressure relief valve seat, both of which are part of the accessory case on the back of the engine.

The pressure relief valve is what regulates oil pressure, and the damage to the pressure relief valve seat is what caused the low oil pressure indication. The effect of that damage would have been mainly at low rpms (e.g., taxi and runup) and most likely would have been barely noticeable in flight.

The engine required a new accessory case (about \$7,000) and a new cluster gear (about \$3,000). The remainder of the cost would be for labor and miscellaneous parts. The Liberty owner summed this all up succinctly: "This sucks, but it's part of plane ownership, I guess." **AOPA**
