Good eyes

Maintenance-induced problems are common, and it often takes an experienced pair of eyes to diagnose them

BY MIKE BUSCH

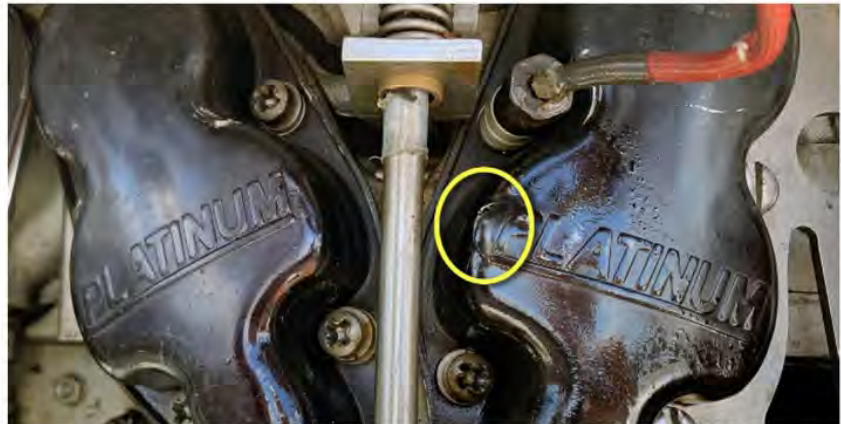
"Check out the valve cover picture that Jack's sent," Tony told Al. "Looks to me like the cover is cracked and bulged out. Possibly the bolts securing the rocker shaft came loose. Hope not, but it looks possible. Shop on the field can't look at this until tomorrow. Can you get a new valve cover overnighted to Elko?"

ONE OF JACK'S SMARTPHONE photos caught Tony's experienced eye.

Al checked with the Sacramento service center and located a valve cover. It was too late to ship the part out that day, so Al arranged for it to be overnighted on Friday, together with a new gasket and locktabs.

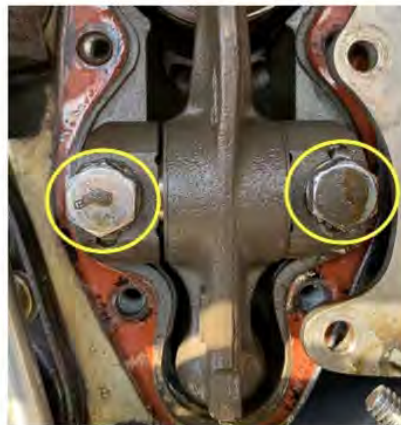
Meanwhile, Jack had removed the damaged valve cover and verified that both bolts securing the rocker shaft had backed off despite the safety locktabs. The rocker shaft was loose and the rocker assembly had been banging against the loose bolt heads, causing them to gouge the inside of the valve cover to the point of cracking it and causing it to leak oil.

LOOSE ROCKER SHAFT bolts in this cellphone photo were noticed by Tony.

That leaves the obvious question: How'd this happen? There's really only one thing that could have caused it to happen, and that is failure to torque the rocker

retention bolts properly before setting the locktabs. These bolts are subject to high repetitive stress, so the integrity of the joint depends pivotally on proper torque (and preload) on the fasteners. If the bolts weren't installed with the requisite torque, there's no way the locktabs could survive for very long.

The new bolts arrived Tuesday morning, and the local A&P installed, torqued, and safetied them; then installed the new valve cover and gasket. The engine compartment and oil-covered fuselage were washed with solvent, and the engine cowlings were reinstalled. An extended runup and

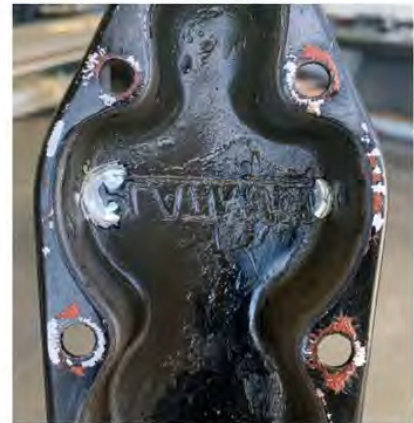
INSIDE OF VALVE COVER gouged by loose bolts to the point of cracking and leaking oil.

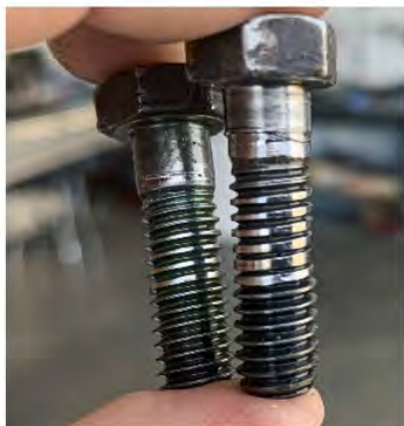
There's no Saturday delivery to Elko, so the new valve cover, gasket, and locktabs arrived on Monday morning. In the meantime, the local A&P at Elko had removed the loose rocker bolts and found that they were badly stripped and stretched and unusable. New bolts had to be overnighted to the FBO.

LOOSE BOLTS were badly stripped and stretched.

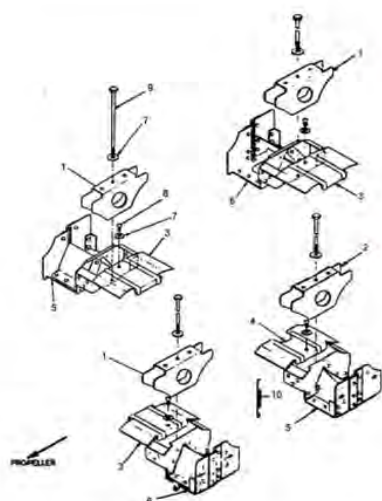
INTERCYLINDER BAFFLES are positioned beneath and between adjacent pairs of cylinders.

Given that only one cylinder was running hot, Jeff and I suspected a possible problem with the engine's intercylinder baffles. These are small, odd-shaped pieces of aluminum that sit beneath and between adjacent pairs of cylinders and prevent cooling air from flowing through the gap

between the cylinders and bypassing the cooling fins.

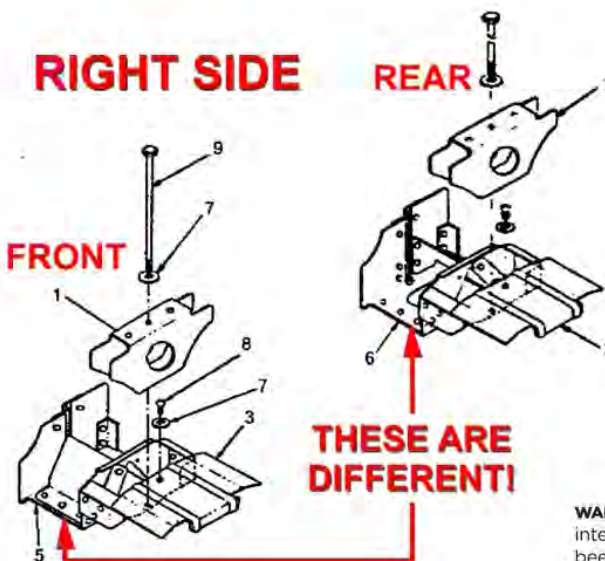
WADE'S RIGHTHAND intercylinder baffles had been installed reversed.

"We have been looking at the engine and I think we may have found the culprit. The intercylinder baffles on the right side of the

engine are installed incorrectly. They are location-specific on the IO-550-N, and the baffles appear to be swapped front to back. This may seem like a minor thing, but we have seen it make a significant difference in the past. I would recommend swapping the baffles into their correct position and performing a test flight."

Bingo! Once the right-hand front and rear intercylinder baffles were moved to their proper locations, the test flight showed that the number 3 CHT had returned to normal, and Wade's two-year quest for a solution was finally over. Once again, this mistake didn't happen at the Continental factory; it happened during cylinder work in the field. A perceptive diagnosis and a sharp set of eyes resolved another elusive maintenance-induced issue. **AOPA**
