Balky alternator

Chasing down an elusive charging system gremlin

BY MIKE BUSCH

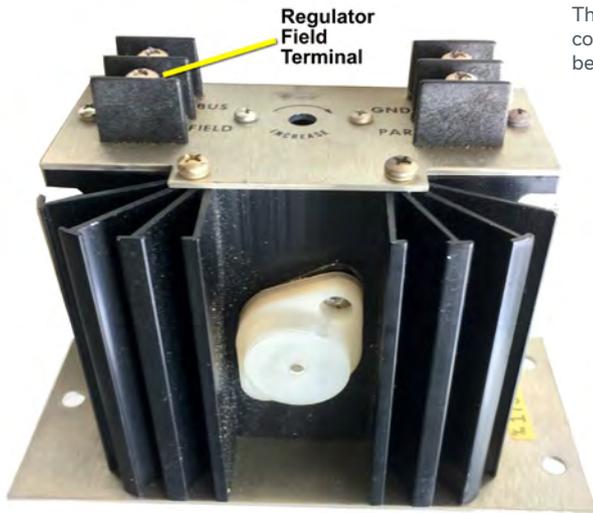
The regulator was the easiest component to get at; it appeared to be functioning normally.

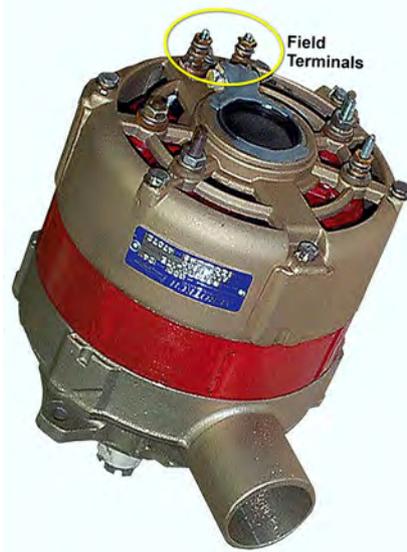
A 100-amp Prestolite ALV9510 alternator costs \$2,200 overhauled or exchanged.

I started making phone calls and finally located a specialty shop in Southern California that was willing to do an “IRAN” on the alternator. (“IRAN” stands for “inspect and repair as necessary” and means “don’t do a full overhaul, just fix what’s broken.”) I boxed up the alternator and took it to UPS. The shop received it the next day and had it repaired, tested,

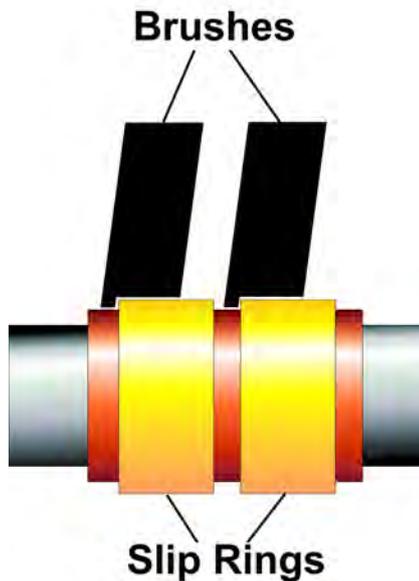
The misaligned brushes developed a “lip,” which caused erratic contact with the slip rings.

Turns out the brush holder was bent so the brushes weren’t properly aligned with the slip rings—probably the result of a sloppy overhaul. The misaligned brushes gradually developed a “lip” where they hung off the edge of the slip rings. In time, the lip got big enough to touch the rotor and prevent the brushes from making proper contact. The solution was simply to bend the brush holder back to its proper shape and install new brushes. The shop also cleaned the slip rings, inspected the rotor, stator, and diodes, put the alternator back together, and bench-tested it. They even threw in a new mounting.
