Spring-loaded to teardown

Does your engine really need to be euthanized?

BY MIKE BUSCH

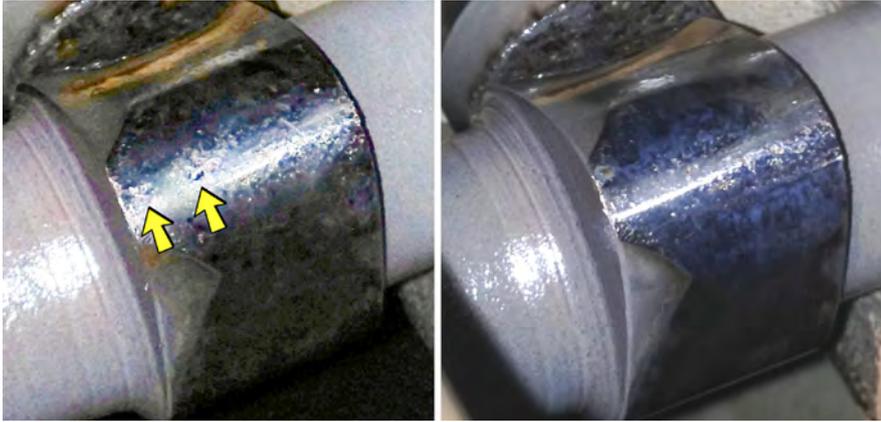
The Continental cam lobe at left has “crack-like features” on its apex and needs to be retired. The one at right has minor distress and should be given the benefit of the doubt with a new lifter.

This nine-page service bulletin is chock-full of photos showing what normal, distressed, and unairworthy cam lobes and lifter faces look like. Continental’s stated criterion for an unairworthy cam lobe is “the presence of indentions or crack like features in the surface along the cam lobe apex” which have sufficient depth to “repeatedly catch” the tip of a sharp pick or awl. Anything less is considered acceptable.

I asked the Skylane owner to email me a high-resolution photo of the cam lobe that had his IA’s knickers in a twist. The photo revealed a cam lobe with some obvious corrosion pitting but definitely no “crack like features” or large indentations on lobe’s apex. My advice to the owner was to sit down with his IA, go over the SID05-1B guidance, and try to persuade him that the appropriate action was to install a new lifter and re-examine it after 100 hours or 12 months to see if it was torn up by the cam (which is the cam’s way of saying

For borderline cases, Continental believes in letting the cam decide its fate: “For minor distress, the camshaft may be continued in service and re-examined upon the accumulation of 100 hours operation or 12 months, whichever occurs first.”

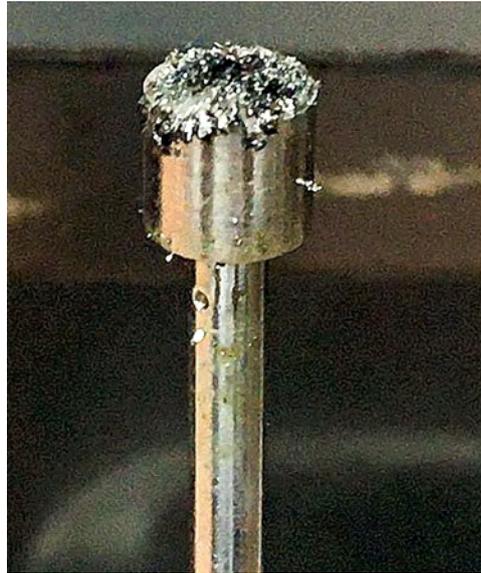
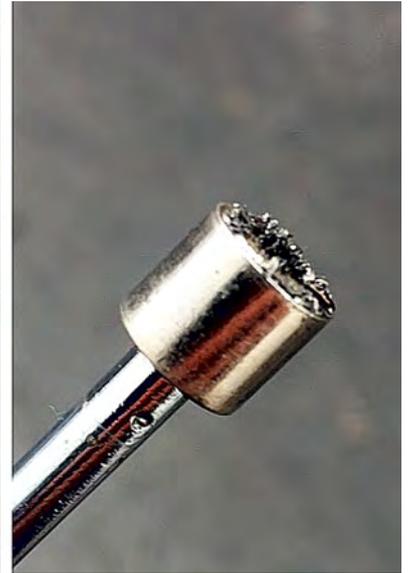
This ferrous metal almost certainly came from the cam of the Lycoming TIO-540, but the fact that the quantity seems to be decreasing is encouraging.

AMS 6414/6415 is low alloy chromium-nickel-molybdenum steel that almost certainly was coming from one or more cam lobes. However, the fact that the quantity of metal seemed to be decreasing was somewhat encouraging. Because I don't consider cam distress as a safety-of-flight issue, I recommended against jumping to any expensive conclusions.

I referred the owner to Lycoming Mandatory Service Bulletin 480F "Metallic Solids Identification After Oil Servicing, and Associated Corrective Action." This service bulletin that provides very specific recommendations for what action to take when metal is found in the oil filter or suction screen. I love SB 480F because it takes such a thoughtful and measured approach. It is the perfect antidote for IAs that want to condemn an engine to euthanasia because a dozen metal flakes were found in the filter. (SB 480F says to fly another 25 hours and recheck the filter to determine which way the needle is moving.)

I recommended that the owner continue to fly the engine, but to recheck the filter and screen frequently following the guidance in SB 480F. I advised that so long as the quantity of metal appeared to be decreasing, he should continue to fly and monitor, but if appeared to be

I also told him that for most Lycoming engines, it was possible to inspect at least a few cam lobes by inserting a borescope into the oil filler or dipstick openings. It would be worthwhile to try to visually inspect the cam in this fashion before deciding to tear the engine down or continue it in service.
