Deadly switches

That ubiquitous key-operated ignition switch is fraught with peril

BY MIKE BUSCH

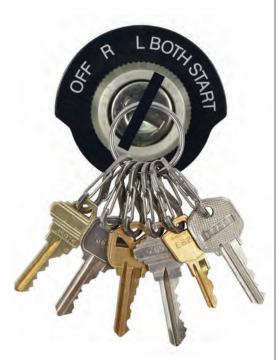
other keys or other paraphernalia hanging from it is a great way to accelerate the wear on the key and the lock cylinder chamber. The combination of weight on the key's head and vibration of a running engine is a prescription for rapid deterioration of switch-to-key integrity.

This is a great way to accelerate wear of your mag switch and ignition key. Don't do it.
