Destructive Detonation

Know the symptoms, and act fast!

BY MIKE BUSCH

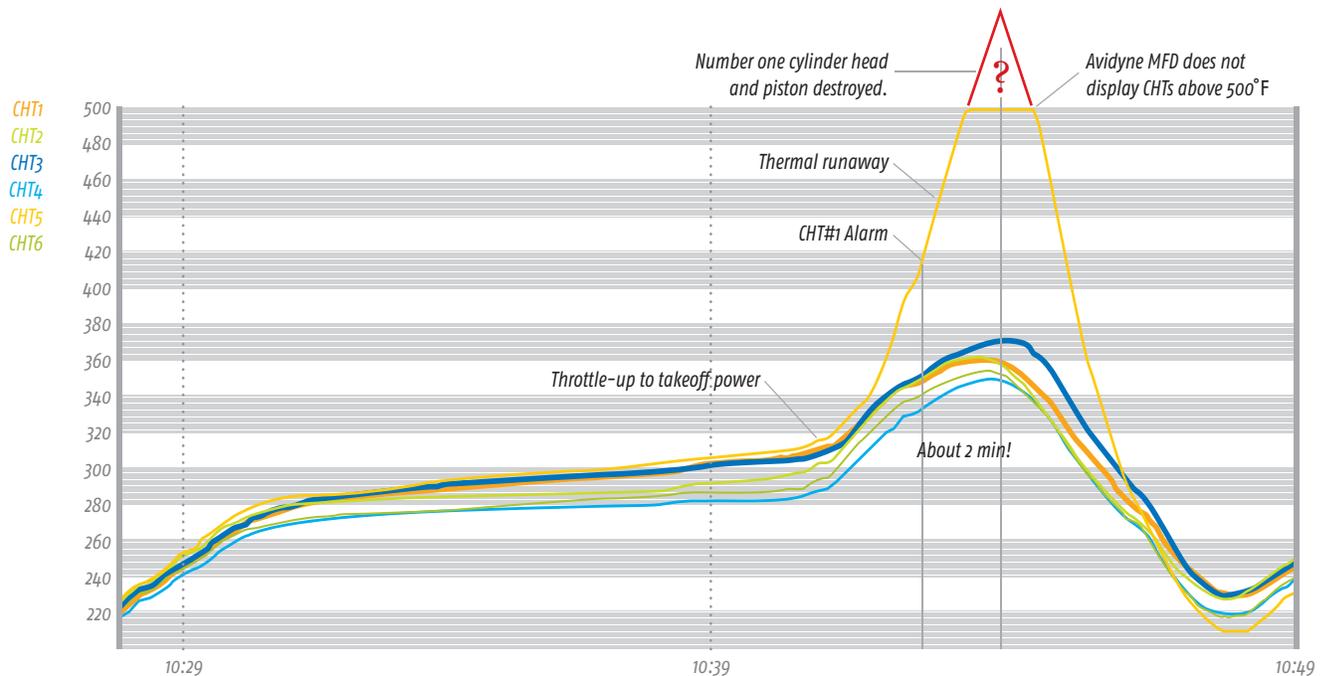
Everything looked fine until about two minutes after the pilot applied takeoff power, at which point the cylinder head temperature

(CHT) of the No. 1 cylinder began to climb rapidly compared to the other five cylinders. At the three-minute mark—with the aircraft at roughly 2,000 feet above ground level—No. 1's CHT rose above 400°F and set off a high-CHT alarm on the MFD.

No. 1's CHT continued its rapid rise—nearly 1°F per second—and continued unabatedly until the piston and cylinder head were destroyed approximately five minutes after takeoff power was applied and

The cylinder head temperature (CHT) data downloaded from the EMax system tells the short tale of the TCM IO-360-ES engine's demise.

only two minutes after the alarm. At that point, since the cylinder was no longer capable of combustion, No. 1's CHT started plummeting.

We can't be sure just how hot No. 1's CHT got because the Avidyne EMax system "pegs" at 500°F. A reasonable guess is that the CHT peaked somewhere between 550°F and 600°F. No cylinder or piston can tolerate such conditions for long, and this one obviously didn't.

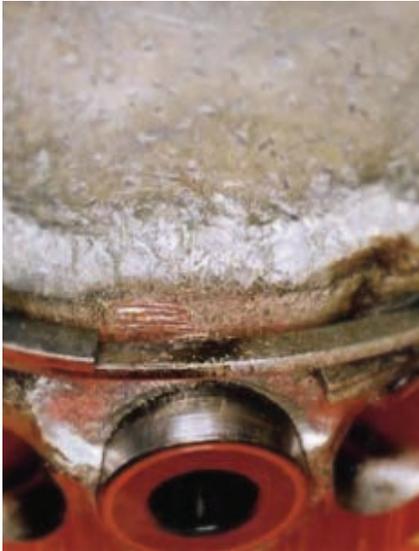
Here's what the No. 1 piston looked like after the event. Note the melted corners of the piston crown, the destruction of the top compression ring lands, and the severe metal erosion above the piston pin.

Note the melted corners of the piston crown, the destruction of the top compression ring lands, and the severe metal erosion above the piston pin (much of this molten metal wound up inside the crankcase and contaminated the bearings and oil passages). Also note the severely hammered and gouged appearance of the piston crown, undoubtedly caused by loose chunks of metal flying around inside the combustion chamber.

The cylinder head was found to have a big chunk of metal missing from it, and both spark plugs were destroyed.

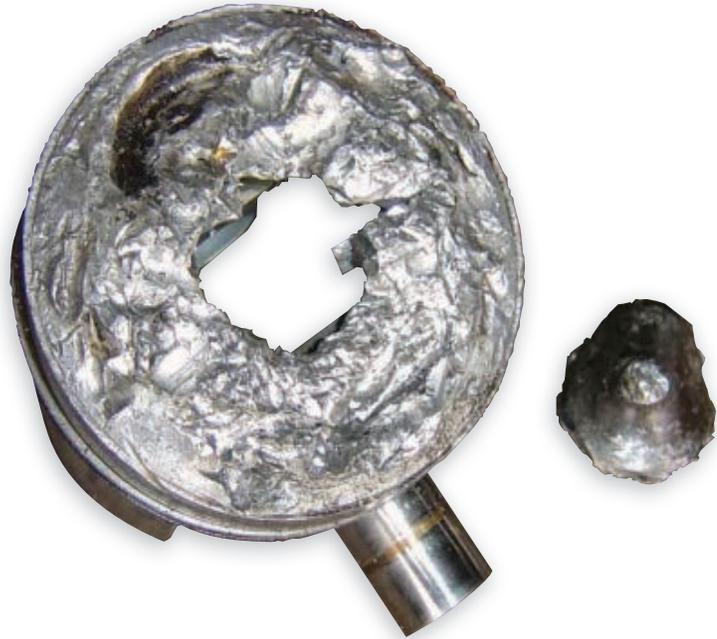
Now that's ugly! The result of thermal runaway and pre-ignition.
