Warranty Schmarranty

That \$40,000 engine turns out to be a lemon...you're covered under warranty, right?

BY MIKE BUSCH

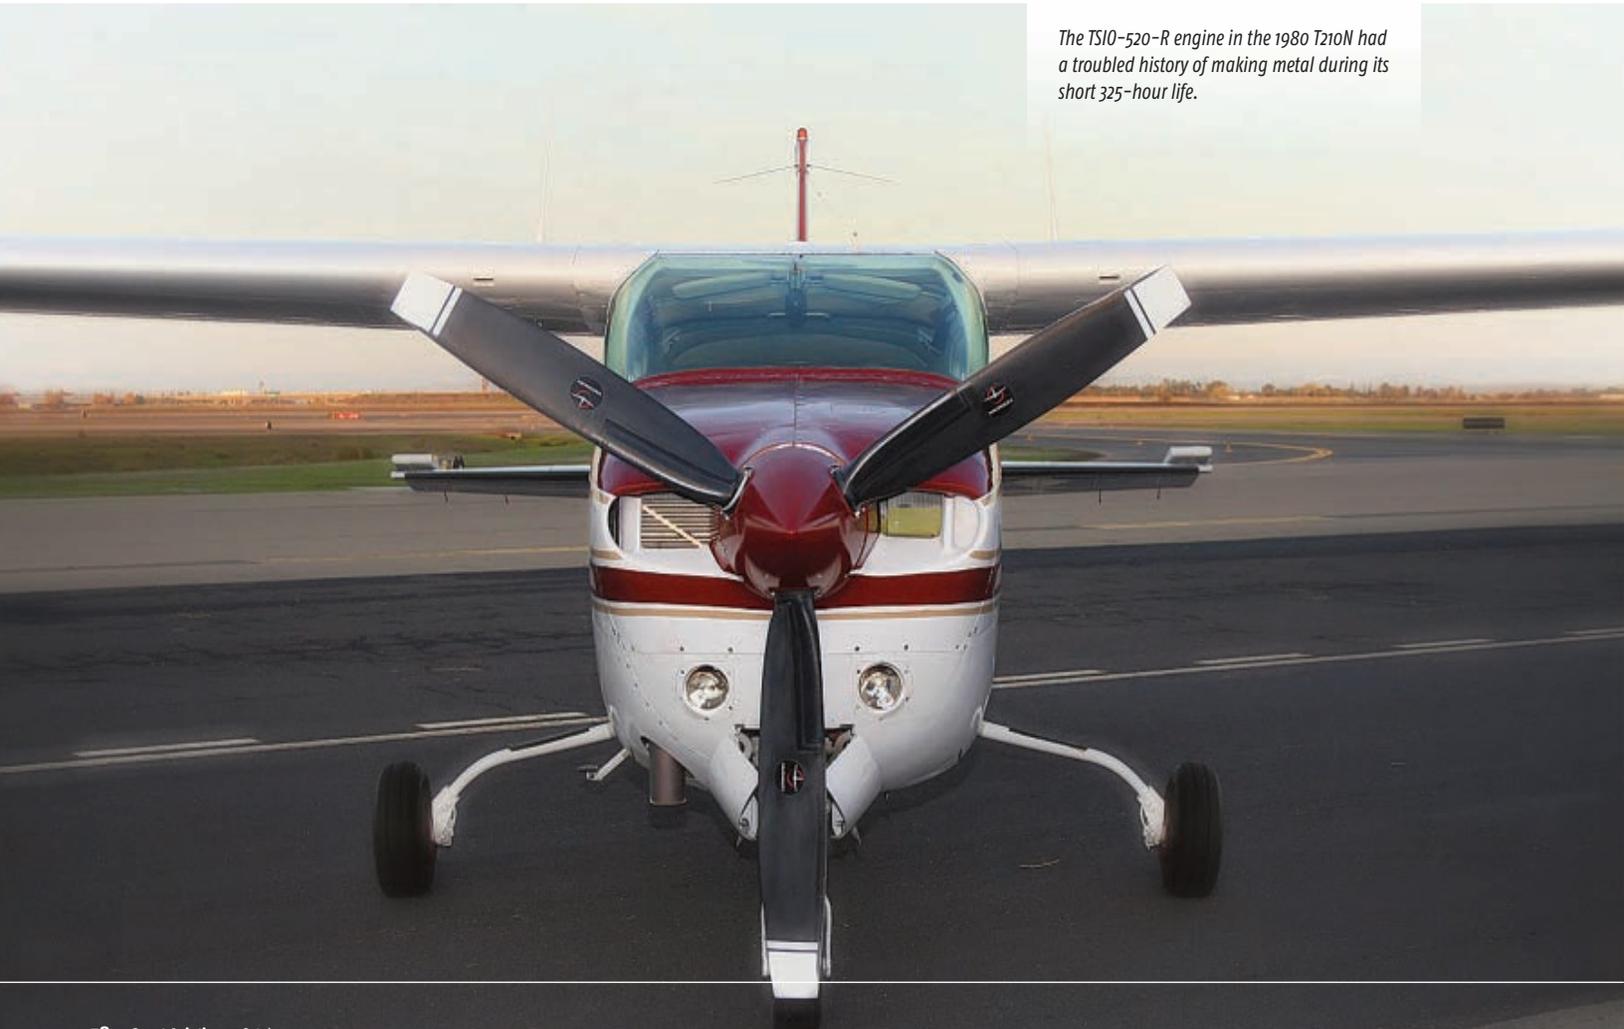
The TS10-520-R engine in the 1980 T210N had a troubled history of making metal during its short 325-hour life.

In April 2009—just 16 months and 154 hours later—a substantial quantity of ferrous metal was found in the oil filter during a routine oil change. Further investigation revealed damage to the oil pump gears. The engine was removed from the aircraft and shipped to the shop that built it for evaluation. The shop performed a complete teardown inspection, and installed new main and rod bearings, new rod bolts and nuts, and a new oil pump. They flushed the oil cooler, turbocharger, lifters, wastegate, starter adapter, and turbo controller and installed an overhauled propeller governor. The engine was shipped back to the owner in early June and reinstalled in the aircraft in early August. This work was covered under warranty.

The SEM report came back from Aviation Laboratories and said that the filter contained “a large quantity of steel flakes compliant with Aerospace Materials Specification AMS 6730” and suggested that the most likely source of this metal was from “camshaft lobes.” This was a bit unexpected, as up until that point we all assumed that the metal in the filter was from the damaged and leaking starter adapter.

Ultimately a decision was made to pull the engine and ship it back to the engine builder for another teardown inspection. Weeks later, the engine shop reported that the engine had been torn down, and (as feared) the starter adapter was damaged and the camshaft was unserviceable. Now the real fun began...
