COMMENTARY / SAVVY AVIATOR

Teardown!

Making the difficult decision to tear down an engine

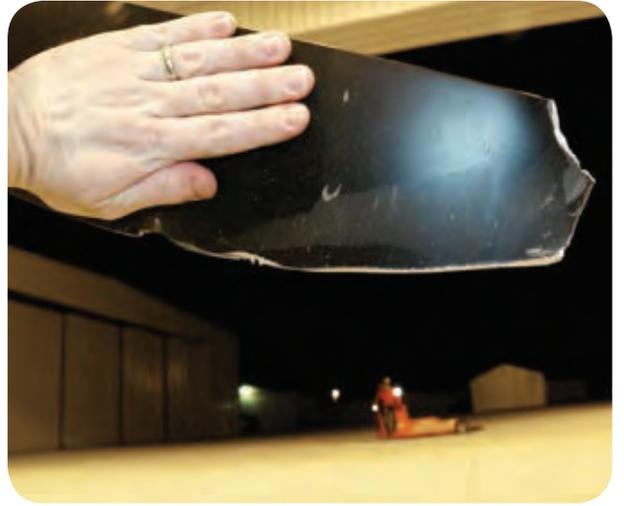
Figure 1—Doing an engine teardown after a prop strike is a no-brainer.

We deal with at least a half-dozen prop strikes a year. Most of these occur in singles, but last month we had a double prop strike in a Cessna 421B that we manage. The pilot had a nose baggage door come unlocked on initial climb-out into a 400-foot overcast, and he made the correct decision to put the airplane down on the remaining runway. Unfortunately, he had started gear retraction before the baggage door flew open. Although the pilot selected gear-down shortly after he made the decision to reject the takeoff, the airplane touched down before the gear was

down and locked, resulting in a double prop strike and some gear damage.

Doing an engine teardown after a prop strike is as close to a no-brainer as these things get. Both Continental and Lycoming are very clear that a teardown inspection is necessary after any event that results in propeller damage, and for Lycomings it's actually required by regulation (AD 2004-10-14), which defines a prop strike as:

If the engine is near or past TBO when the prop strike occurs, savvy owners will often decide to convert the post-prop-strike teardown inspection into a full major overhaul. Although insurance won't cover the full cost of the overhaul, it will provide a substantial subsidy, making the overhaul significantly less costly

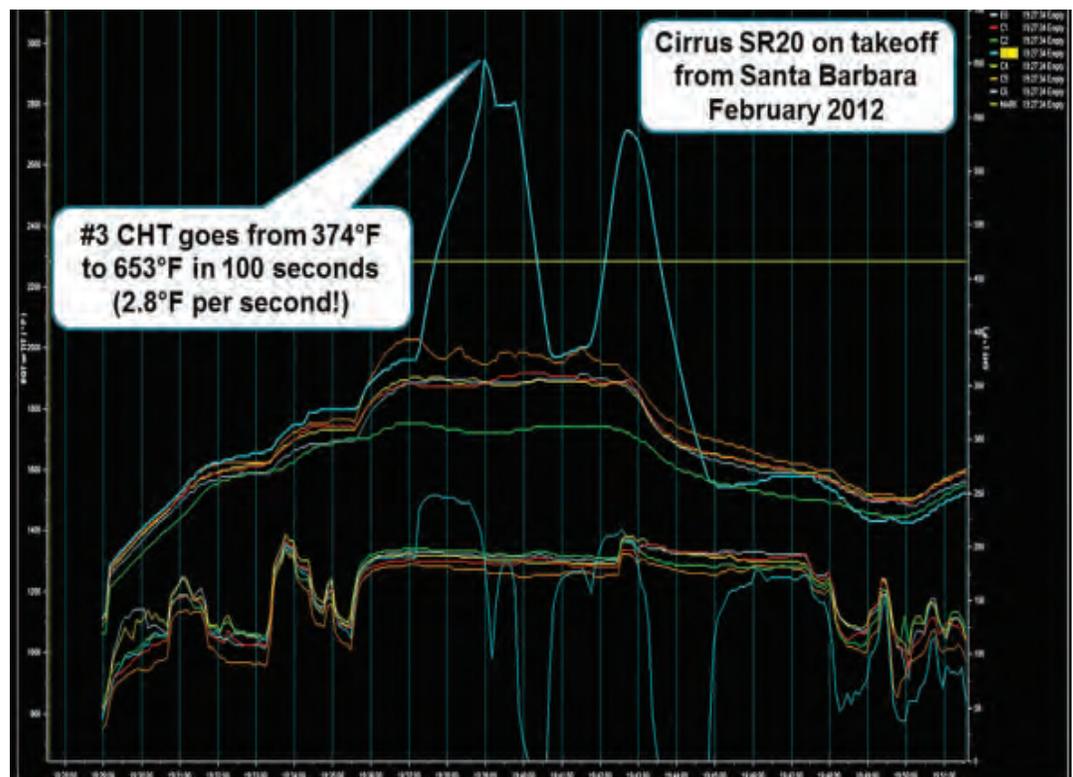
When I studied the engine monitor data (see Figure 2), I could hardly believe my eyes. During a period of just more than a minute and a half, the No. 3 CHT rose

from 374°F (normal) to 653°F (almost 200°F over redline). The rate of temperature rise was 2.8°F per second, the most rapid I'd ever seen in decades of looking at such data.

I knew that only one thing can cause this kind of extreme runaway CHT: a violent preignition event. Such an event occurs when something in the combustion chamber heats up to the point that it starts to glow red-hot and act like a glow plug, igniting the fuel-air mixture prematurely (before the spark plug fires) and creating extreme temperatures and pressure that can destroy the cylinder and piston in less than a minute. I'd seen many of these events in the past, but never one where the CHT rose so rapidly and reached such a high peak.

Figure 2—Dramatic preignition event on a Continental IO-360-ES in a Cirrus SR20.

A few hours later, the DOM reported back his findings: (1) the gold paint on the No. 3 cylinder barrel was black and blistered; (2) the top spark plug was loose and had backed out nearly a full turn, stopped at that point only by the ability of the ignition lead to twist; (3) the bottom spark plug was just barely more than finger tight; (4) the spark plugs on the other five cylinders were seriously undertorqued, requiring between 1 and 1.5 "flats" to get them up to specified torque; (5) the piston crown was melted over about one-third of its circumference all the way down to the top compression ring groove; and (6) both No. 3 spark plugs were packed with aluminum (presumably from the melted piston).

was failure of the shop that performed the last annual inspection on this aircraft to torque the spark plugs properly. When the top No. 3 plug started to back out, it lost its normal heat conduction path through the copper gasket to the cylinder head.

Without its normal heat sink, the spark plug became so hot that some portion of it started to glow red-hot and triggered the violent preignition event that followed.

At this point, it was obvious that the cylinder and piston would have to be replaced. We instructed the DOM to not even attempt to repair the cylinder, because with a CHT of 653°F, we believed that the metallurgy of the cylinder head had been so badly compromised that its only appropriate use would be as a lamp base. The piston was so badly damaged that it took the shop four and a half hours of labor and some clever work with a hydraulic "Jaws of Life" tool to extract the piston pin and remove the piston from the connecting rod. Fortunately, the connecting rod bushing was still in good shape.

Fortunately, the prop governor gasket screen was clean, and we concluded that all the metal from the melted piston had been caught by the oil filter. We asked the shop to drain the oil, change the filter, and service the sump with clean oil. The No. 3 cylinder and piston were replaced with new ones from Continental. Three weeks after the incident, the owner finally flew his airplane home. We asked him to schedule a short 25-hour oil change, filter inspection, and spectrographic oil analysis just to make sure all the liberated aluminum was out of the engine.

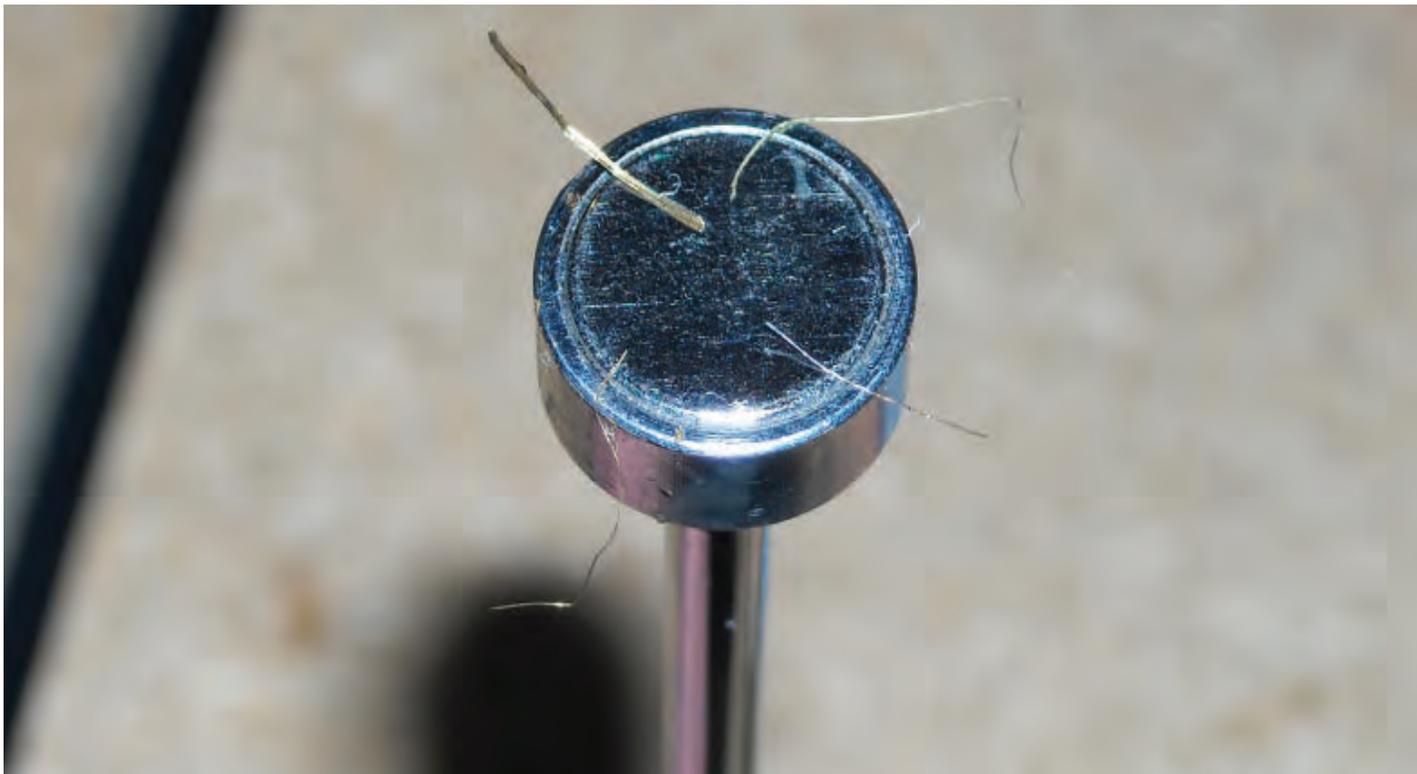
Figure 3—Ferrous metal whiskers, probably from a spalled lifter or cam lobe.

Bellanca Super Viking 17-30A powered by a Continental IO-520-K. (Decades ago, I owned the very same make and model.) At the last oil change, the mechanic inspected the oil screen and found a substantial quantity of ferrous metal whiskers. The Bellanca owner was looking for advice on what to do. In my experience, such ferrous whiskers almost always come from cam and lifter spalling.

screen. He reported back that two ferrous whiskers were found in the gasket screen.

At that point, I sadly told the owner that I had no choice but to recommend the engine be torn down. The fact that the metal was found in the prop governor gasket screen meant that it had made it past the oil screen (which probably clogged up and went into bypass) into the main oil galleries of the engine, and almost certainly contaminated the bearings. Game over.

Had this owner retrofitted his engine with a full-flow oil filter, chances are good that all the metal would have been caught by the filter and the teardown avoided. I suspect that's the first thing he'll do after the engine comes back from the engine shop. *EAA*
