MIKE BUSCH

Diagnostic Tales From the War Zone

Troubleshooting is best accomplished by first gathering data and then analyzing it logically

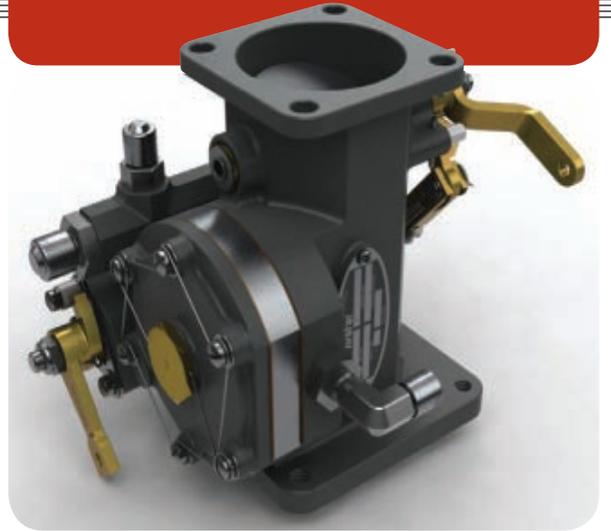
Figure 1—Two local mechanics decided that the RSA fuel servo was the culprit.

The owner took the aircraft to a local mechanic, who ran the engine and concluded that the RSA fuel servo was at fault. He discussed the problem with another technician, who agreed with his diagnosis. The mechanic proposed to remove the RSA fuel servo and overnight it out to Precision Airmotive for bench testing and repair. This would leave the aircraft grounded and the owner stranded in Key West for a week. The estimated cost for an overhauled fuel servo was about \$2,000.

Lycoming “morning sickness” caused by a sticky exhaust valve. Paul explained to the owner that the symptoms could not possibly be caused by a faulty RSA fuel servo, since there is no way that a fuel servo problem could affect just one cylinder.

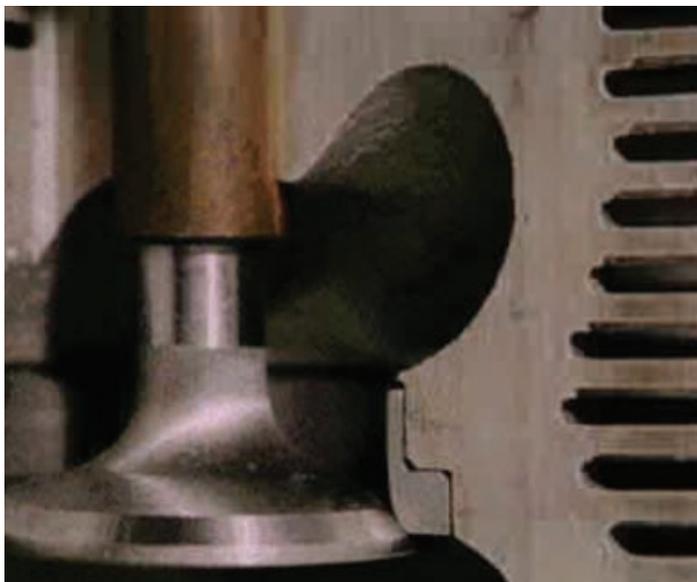
plugs, the engine ran a bit better. The engine smoothed out after several more ground runs, reinforcing Paul's diagnosis of a sticky No. 3 exhaust valve (which would be worst when cold and would free up as it heated up). At that point, the owner decided to fly his T182 home—which he did without incident—and have his regular mechanic ream the No. 3 exhaust valve guide. This appears to have resolved the issue once and for all.

Figure 2—Lycoming "morning sickness" is caused by buildup of exhaust deposits on the exhaust valve stem and inside the exhaust valve guide. The cure is to clean the valve stem and ream the valve guide, something that can be done without removing the cylinder.

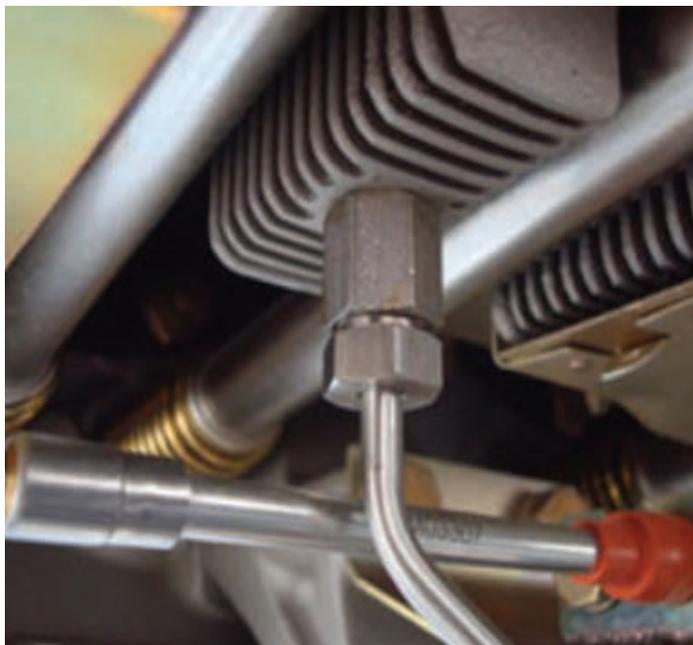
Our review of the data immediately confirmed our suspicions that the No. 6 CHT indication was bogus. At one point, its value changed more than 40°F between two adjacent data samples spaced six seconds apart. A 40°F change in CHT in six seconds is simply not possible—it defies the laws of physics. I've studied literally thousands of flights, and the most rapid CHT change I've ever seen—during a destructive pre-ignition event that wound up melting the piston—was about 1.5°F per second. This one

Figure 3—The CHT probes in Cirrus aircraft are notorious for failing and providing erroneous CHT data.

changed 7°F per second, and that’s simply not plausible. Clearly, the CHT No. 6 indication was lying, due either to a faulty probe or a bad connection.

We asked whether it was possible to have the No. 6 and No. 4 CHT probes swapped to verify that the anomalous CHT indication remained with the bad probe. Unfortunately, there were no services at this airport, and no mechanic available to swap the probes. After reviewing the engine monitor data, we were sufficiently confident in our diagnosis that we recommended that the owner fly the airplane home and have the CHT indication problem debugged there. The flight was uneventful, and the new engine is breaking in just fine.

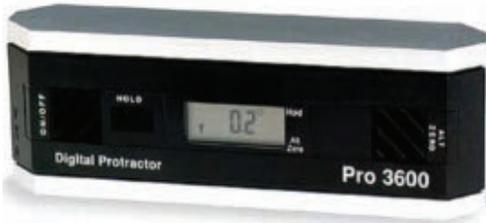
Figure 4—The \$360 Pro 3600 digital inclinometer turned out to be off by 3 degrees. The old-fashioned E25 “flowerpot” timing indicator got the job done.

was that at full takeoff power from approximately sea level, both post-annual flights had CHTs about 50°F higher and EGTs about 50°F lower than the pre-annual benchmark flight. I explained to the owner that this could mean only one thing: advanced magneto timing. I understood that the shop had just checked the mag timing and found it spot-on, but I also knew that the engine data wasn't lying, so I urged the owner to have the shop check the mag timing again. I said that the high-CHT/low-EGT condition I was seeing in the data would require that at least one magneto had timing advanced by 3 to 5 degrees.

Two hours later, I spoke with the DOM and the shop. He explained that he rechecked the mag timing, but this time instead of using the shop's fancy \$360 digital inclinometer, he used the old mechanical "flowerpot" timing tool that he'd used for more than 30 years before buying the digital unit. The flower pot revealed that the timing of both mags was advanced 3 degrees beyond the proper timing specification. The shop's \$300 digital inclinometer was off by 3 degrees. (I later learned that one of the technicians had accidentally dropped it on the concrete hangar floor, and it was never quite the same after that.)

You know the rest of the story. The shop readjusted the mag timing using the old flowerpot method, and the owner flew home with his EGTs and CHTs right where they were supposed to be.

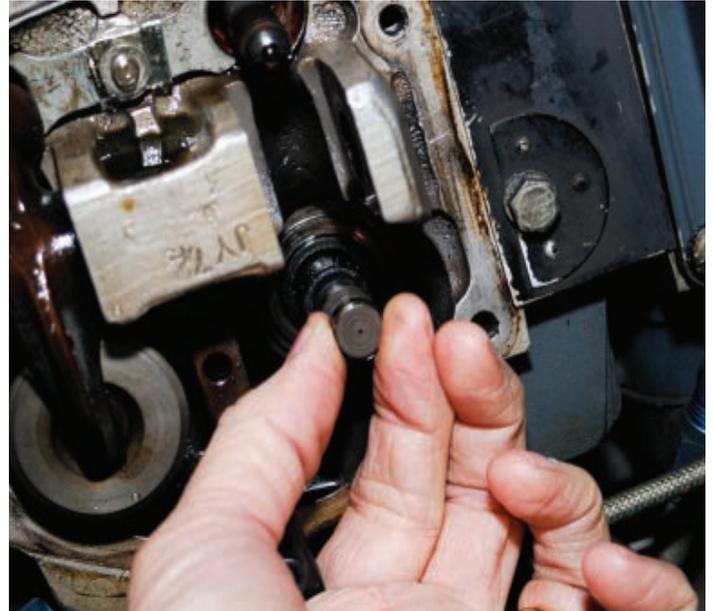
Figure 5—it makes no sense to do this sort of invasive exploratory surgery before first dumping and analyzing data from the digital engine monitor.

I checked compression No. 6 cylinder, 67/80 no leakage through the valves. I could hear some leakage through the rings until they clicked and seated during the compression check. I removed valves springs on intake and exhaust and found no excessive play in the guides, and all valves moved freely. I performed a third compression check of cylinder No. 6 with no valve springs installed and got 67/80. All lifters were replaced with new when the engine had a top overhaul about 900 hours ago. Lifters also were not found collapsed when rockers and springs were removed on the No. 6 cyl.

This airplane has a JPI engine monitor. Why didn't anyone think to dump the data and have it analyzed before starting to perform exploratory surgery on this engine—pulling spark plugs, fuel nozzles, rocker arms, valve springs, and so forth? To my way of thinking, that's like having a cough and going directly to a thoracic surgeon without first seeing an internist or radiologist for a physical exam or an X-ray. I e-mailed the IA and suggested he dump the JPI data and upload it so I could take a look at it. Film at 11. **EAA**
