MIKE BUSCH

A Little Dab'll Do Ya—In

Even a seemingly trivial mistake by a well-intentioned mechanic can have dire consequences

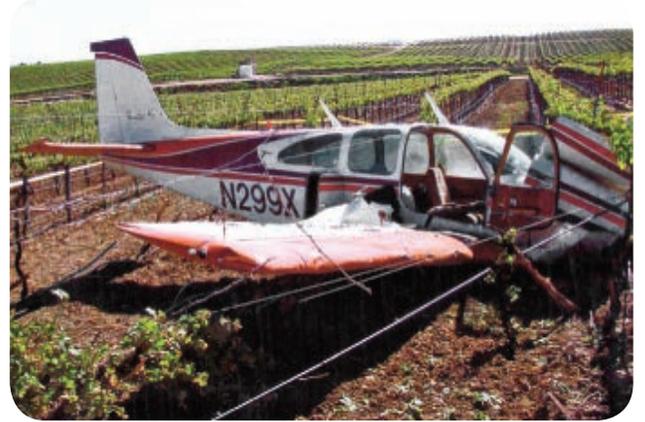
Figure 1—The Debonair made a forced landing in a vineyard 2 miles short of the Paso Robles airport. The aircraft was not equipped with shoulder harnesses, and the pilot and passenger both sustained serious head injuries.

He set up for an off-airport landing in what he thought was a green field about 2 miles short of the airport. At the last minute, he realized that it was a vineyard and his flight path was at a 45-degree angle to the rows. The pilot extended the landing gear in an attempt to mitigate the impact, but the left main gear snagged a grapevine row pole and wires. The aircraft veered left and stopped abruptly.

restraints. (Shoulder belts were not offered by Beech when the airplane was built in 1966, and no regulation required that they be retrofitted.) Both pilot and passenger sustained serious injuries when their heads struck the instrument panel. The 44-year-old passenger was knocked unconscious, and his head trauma tragically resulted in permanent brain injury.

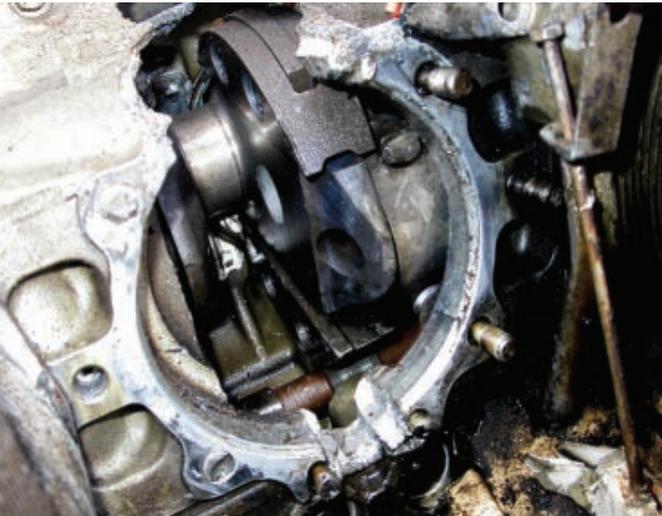
The post-accident engine examination revealed that the No. 4 cylinder and piston had departed the engine in flight; they were never recovered. The two right-hand cylinder hold-down studs appeared relatively undamaged, but their hold-down nuts had backed off. The four remaining hold-down studs were sheared, and both through-bolts were sheared as

well. The No. 4 connecting rod punctured a 3-inch by 7-inch hole in the top of the crankcase. The No. 4 connecting rod, cap, and rod bolts and nuts were recovered from inside the engine cowling, as were most of the sheared-off studs, through-bolts, and nuts.

The NTSB concluded the obvious: “The National Transportation Safety Board determines the probable cause(s) of this accident to be the separation of the No. 4 engine cylinder due to improperly torqued cylinder hold-down nuts. A finding in this accident was the lack of a shoulder restraint system in the airplane, which contributed to the occupants’ injuries.”

Figure 2—The NTSB examined the Debonair’s engine and found that the No. 4 cylinder and piston had departed the engine in flight.

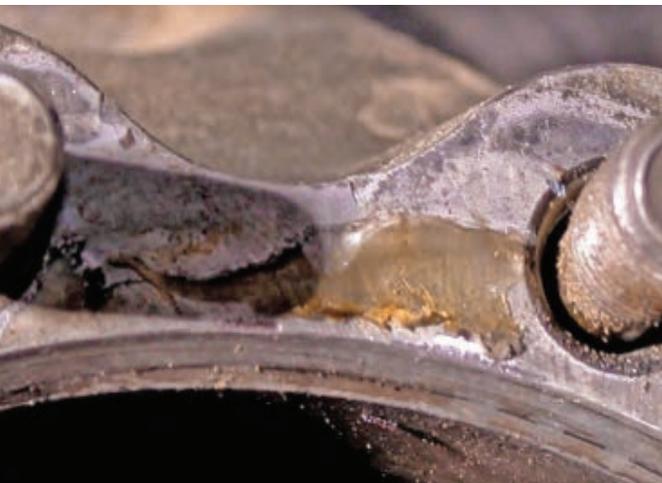
The mating surfaces of the crankcase’s cylinder deck and the cylinder’s mounting flange need to be perfectly clean when the cylinder is mounted and its hold-down nuts are torqued up. Any sort of contamination of those surfaces—even a thin coat of paint—is enough to cause the hold-down studs to lose their pre-load and ultimately to fail. The presence of even a tiny dab of flexible sealant on the mating surfaces could have disastrous consequences. Any competent A&P mechanic who works on piston aircraft engines knows this (or at least should know it).

Figure 3—The “smoking gun”—sealant on the cylinder deck. But how did it get there?

indeed an uncoated oil seal and therefore the use of Gasket Maker was appropriate. So the apprentice mechanic applied Gasket Maker to the cylinder base O-rings before installing the four cylinders on the Debonair's engine. When he torqued down the cylinder hold-down nuts, the sealant on the O-rings was extruded onto the mating surfaces of the cylinder base flange and the crankcase cylinder deck. About 150 hours later, the No. 4 cylinder departed the engine and the Debonair fell out of the sky.

Apply Gasket Maker only as directed. The improper use of sealants may cause engine malfunction or failure. Do not apply any form of sealant to the crankcase cylinder deck, chamfer, cylinder mounting flange, cylinder base O-ring, or cylinder fastener threads. The use of RTV, silicone, Gasket Maker, or any other sealant on the areas listed above during engine assembly will cause a loss of cylinder deck stud or through-bolt torque. Subsequent loss of cylinder attachment load, loss of main bearing crush, and/or fretting of the crankcase parting surfaces will occur. The result will be cylinder separation, main bearing movement, oil starvation, and catastrophic engine failure. Use only clean 50 weight aviation engine oil on surfaces listed. EAA

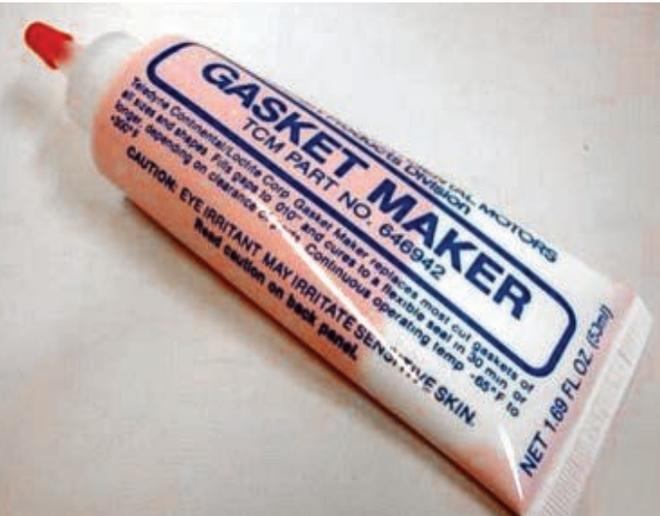
section, he found a reference to Gasket Maker that listed a number of specific applications, followed by a catch-all item indicating that Gasket Maker was appropriate for use on "all uncoated oil seals."

The jury might have let TCM off the hook altogether but for one thing: TCM's expert conceded under cross-examination that TCM knew of other incidents where its engines came apart because mechanics had applied Gasket Maker to cylinder base O-rings, yet had not revised its manuals to make it clear that this was not an acceptable use for the product.

Figure 4—The TCM maintenance manual said that Gasket Maker could be used on "all uncoated oil seals." That turned out to be misleading.

As a result of this lawsuit, Continental has added the following warning to its technical publications:

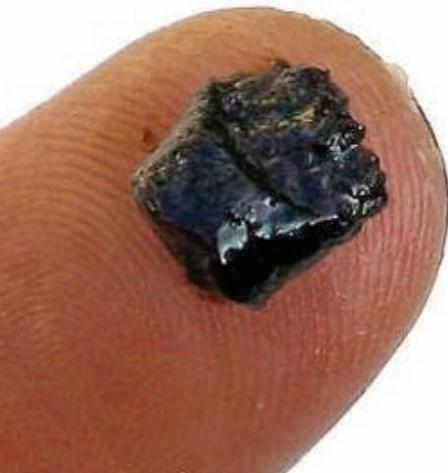
In a videotaped deposition, the young mechanic who had installed the cylinders in June 2004 readily admitted that he had applied a sealant called Gasket Maker (TCM Part No. 646942) to the cylinder base O-rings when he installed the four cylinders. He had installed cylinders on TCM engines on a number of prior occasions and was quite familiar with the process. However, this was the first time he’d ever applied Gasket Maker to the cylinder base O-rings.

Figure 5—Here's what a \$15 million dab of Gasket Maker looks like.
