COMMENTARY / SAVVY AVIATOR

A Highly Modified Skyhawk

How does an IA deal with a situation like this?

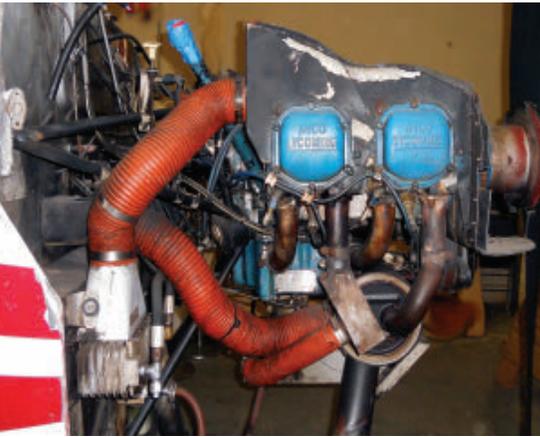
In 1986 the club installed the Pearce high-compression STC (SE1226CE) and the Pearce prop twist STC (SA1225CE). These alterations increased rated takeoff power from 150 hp to 160 hp (limited to five minutes), compression ratio from 7.0 to 8.5, prop pitch from 53 inches to 57 inches, maximum static rpm from 2370 to 2400, and minimum avgas grade from 80 to 100. (Both of the Pearce STCs are now owned by Ly-Con Aircraft Engines.)

The 1976 Skyhawk's original 150-hp Lycoming O-320-E2D engine and 53-inch pitch prop was modified with a high-compression piston STC and a 57-inch pitch prop STC to produce 160 hp.

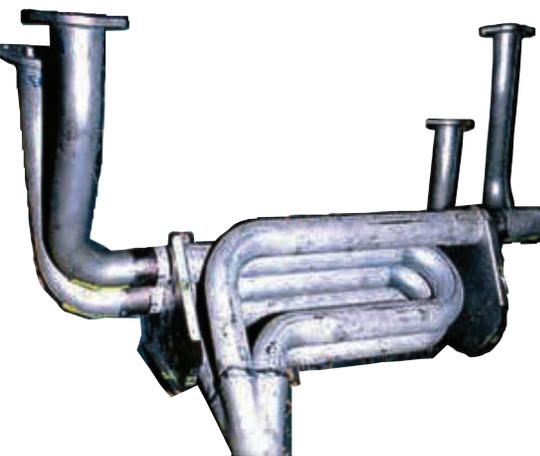
In 2000, the club further modified the Skyhawk by installing a Power Flow tuned exhaust system (STC SA01801AT). This is considered by the FAA to be an airframe alteration rather than an engine alteration (which is why the STC number starts with “SA” rather than “SE”), but the purpose of the tuned exhaust system is to increase engine horsepower and fuel efficiency. Power Flow does not make any specific horsepower increase claims, but it does claim that most fixed-pitch Cessna 172 customers report an increased rate-of-climb of 150 to 225 feet per minute. Assuming an aircraft weighs 2,300 pounds with a prop

efficiency of 80 percent, that would calculate out to a climb power increase of 13 to 20 hp. This suggests that the Skyhawk's modified O-320 might be putting out 173 to 180 hp on takeoff.

Indeed, the club found that the 57-inch pitch prop was "overpowered" by the modified engine. Club members reported a number of episodes of engine overspeed. In 2008, the club had a prop shop increase the pitch even further, which helped with the overspeed issue according to the club's maintenance officer. Indeed, the Power Flow Systems website FAQ page states:

The tuned exhaust system from Power Flow Systems probably added an additional 13 to 20 hp, causing the owners to have the prop pitch increased further.

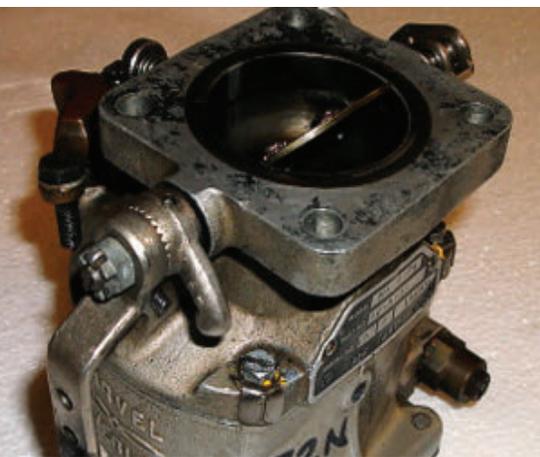
Meanwhile, in 2006 the club performed a top overhaul on the engine when three of the four cylinder heads exhibited excessive heat signatures. It installed a digital engine monitor, which showed excessive CHTs during climbs, especially at higher altitudes. The club imposed amended climb procedures to keep CHTs better controlled. But when the engine underwent major overhaul, the engine shop found annealed compression rings. During post-overhaul test flights, it was determined that the cylinders were running too lean even at full-rich mixture. As a result, the engine shop had the carburetor re-jetted to increase full-power fuel flow from 12.5 gph to 13.5 gph. And the club revised its operating procedures to make them more conservative and less abusive.

The O-320's carburetor was re-jetted to increase takeoff fuel flow from 12.5 to 13.5 gph.

FAR Part 43 Appendix A provides guidance to mechanics as to whether a particular alteration is major or minor. After reviewing that guidance, I became convinced that both re-jetting the carburetor and re-pitching the propeller beyond the 57-inch pitch constituted major alterations that required field approvals. Just to be sure, I checked with my principal maintenance inspector at the FSDO, and he agreed that they sound like major alterations to him, too.

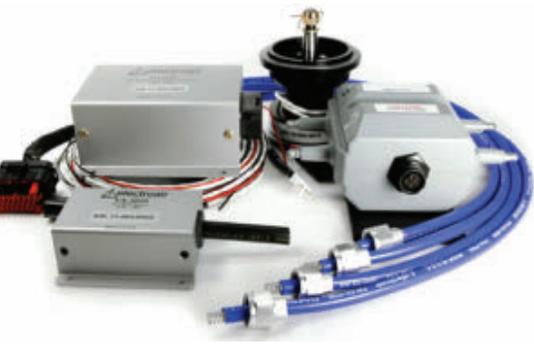
Finally, in 2013—just before the club enrolled the Skyhawk in our managed maintenance program—the right magneto was removed and replaced with an Electroair electronic ignition system (STC SA02987CH). This system produces a hot, long-duration spark and incorporates a manifold pressure sensor and a controller that advances the ignition timing far beyond Lycoming's standard 25 degrees BTDC (before top dead center) at reduced manifold pressures. Electroair claims that this provides increased horsepower, better high-altitude performance, and significantly improved fuel economy.

The O-320's right magneto was replaced with an Electroair electronic ignition system.

So...are the four STCs installed on the Skyhawk compatible? I still don't have a good answer, but frankly I'm not at all comfortable that they are. Each of the STCs increases engine horsepower. Each of the STCs was approved by the FAA on the assumption that it was the only horsepower increase STC being applied to the Lycoming O-320. Combining them all together struck me as being eerily similar to the Skymaster with the STOL kit, tip tanks, and winglets. And the heat-distressed cylinder heads and annealed compression rings seemed like warning signs.
