National Transportation Safety Board

Safety Recommendation Report

Stratus Oil Filter Adapter Assembly Oil Leaks

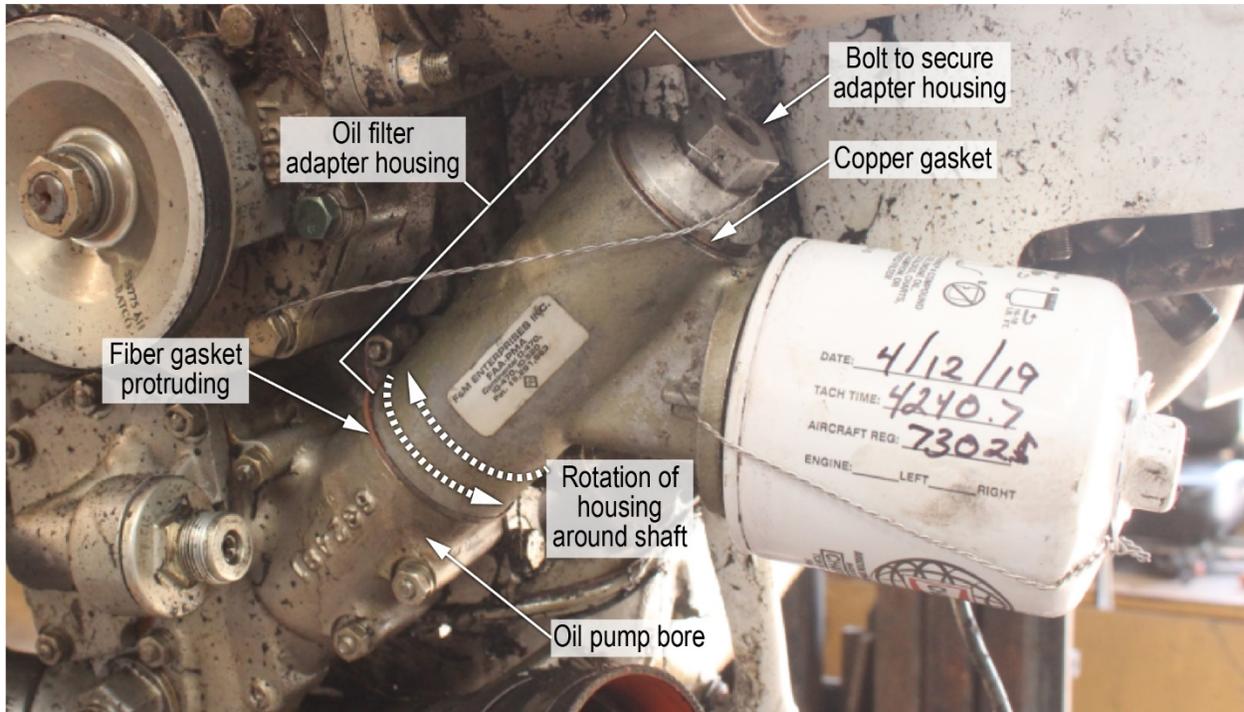
Figure 1. Mill Creek accident oil filter adapter attached to the engine.

Postaccident examinations of the oil filter adapters on the Ramona and Mill Creek accident airplanes revealed a crescent indentation in the fiber gasket material. Further, investigators found that the housing for both accident airplanes’ oil filter adapter rotated freely around the shaft and the fiber gasket protruded from the interface between the oil pump bore and adapter. Postaccident

examinations of the accident adapters from the Ramona and Mill Creek accidents revealed that the torque was 9 lbf-ft and less than 20 lbf-ft, respectively. However, investigators were not able to determine the root cause of these irregularities.

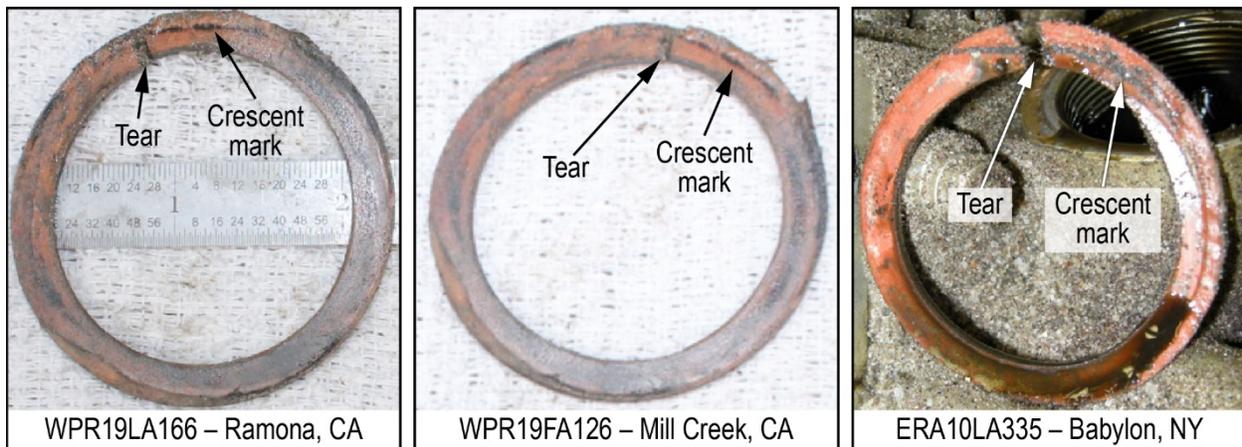
Gaskets rely on both friction and even compressive force (also called seating stress) to create a seal between mating surfaces. One of the signatures of uneven gasket compression is uneven impression marks around the gasket; if the gasket is not positioned flat during installation (for example, the housing is torqued while the gasket is canted), uneven compression could occur or the gasket material could be torn.

A review of NTSB accidents and incidents showed that the two oil filter adapter leaks and gasket ruptures cited above were not isolated events.⁵ Figure 2 shows the torn fiber gaskets and crescent marks from the two accidents described above and from a June 25, 2010, accident that occurred following an oil leak, a total loss of engine power, and a forced landing near Babylon, New York.⁶ In addition, at least 10 other accidents or incidents occurred in which the airplane was equipped with an F&M or Stratus oil filter adapter and had a loss of engine power following an oil leak; 5 of those included evidence of torn fiber gaskets and crescent marks and 4 of those had loose adapters. Some of the issues identified in those accidents and incidents included misalignment of the gasket and adapter, use of a copper gasket instead of a fiber gasket, undertorqued oil filter adapters, missed or undocumented adapter retorques, and gaskets that had not been recently replaced.

Figure 2. Torn gaskets with crescent marks from three different accidents.

In response to the findings of the ongoing investigations and other reports of oil leaks, on October 25, 2019, Stratus issued a mandatory service bulletin (SB), SB-001, to the owners of affected aircraft. Stratus' SB instructs mechanics to inspect the adapter for leaks, gasket damage or protrusion, and movement of the assembly; reinstall the oil filter adapter, if necessary; tighten the cylinder torque to 65 lbf-ft; and install safety wire. The SB instructs owners to inspect oil adapters before the next flight, every time the oil is changed, each 100-hour or annual inspection, and whenever the adapter is removed and installed. The SB also instructs mechanics to make an index mark on the adapter housing and the oil pump bore and calls for a wooden block to be placed behind the adapter to ensure that the adapter housing does not rotate while increasing the torque. The FAA has not issued an airworthiness directive (AD) mandating compliance with Stratus SB-001.

Issue an Airworthiness Directive to address the unsafe conditions of F&M Enterprises Inc. or Stratus Tool Technologies (Stratus) oil filter adapters that have led to oil starvation and loss of engine power by requiring owners of airplanes equipped with the adapters to repetitively inspect and, if necessary, reinstall the adapters in compliance with Stratus' service bulletin SB-001. (A-20-39)
