# Hostage situation

Don't fall victim to an overzealous mechanic

BY MIKE BUSCH

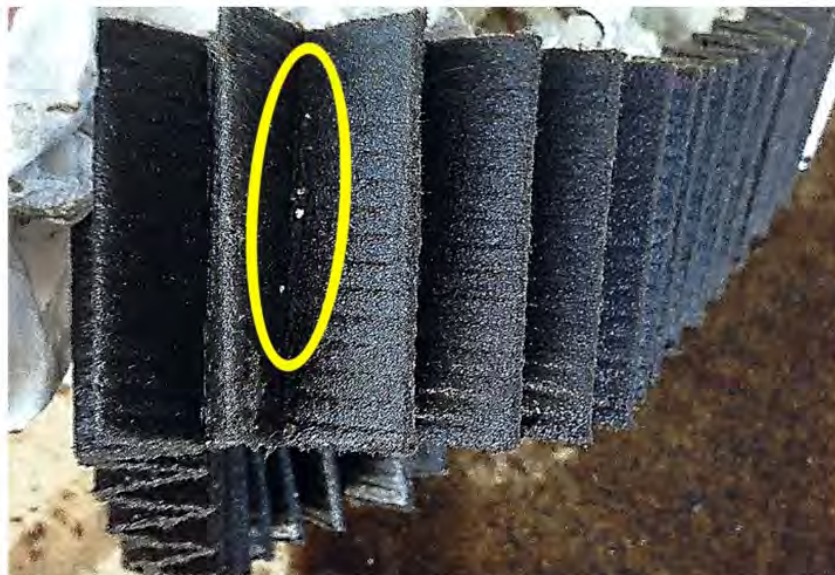
I examined the photos under magnification and saw only a small amount of what appeared to be aluminum. It didn't strike me as being a significant quantity, and it certainly didn't appear to be bearing material. This didn't seem like anything that justified the drastic step of tearing the engine down.

**THE PHOTO** of Mark's oil filter didn't exhibit anything exciting.

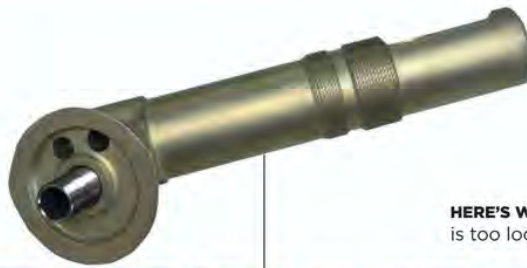
**THIS CESSNA** oil filter adapter is the subject of a recurring AD to make sure the jam nut is torqued properly.

Two weeks later, Mark's airplane went in for its annual inspection, and we found the source of that pesky bit of aluminum that had lodged in the pressure relief valve and initiated all this drama. The shop discovered that the engine's oil filter adapter jam nut hadn't been torqued properly at the previous annual inspection—this is the subject of a recurring AD—allowing the adapter to vibrate and tearing up some of the aluminum threads.

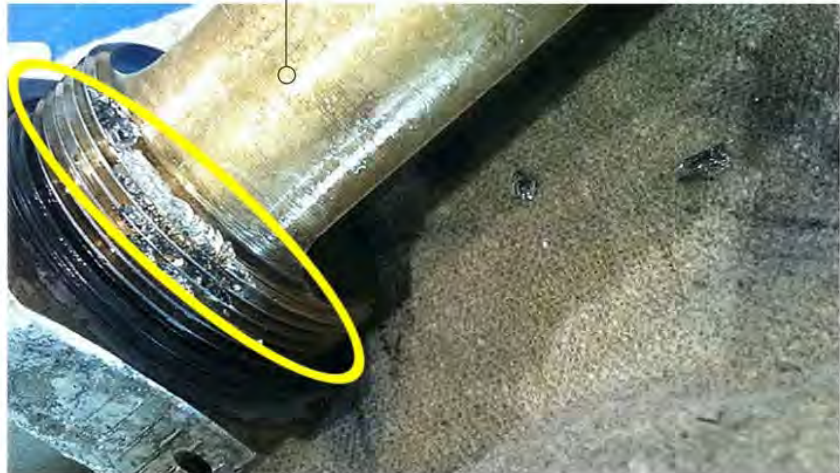
**HERE'S WHAT HAPPENS** when the jam nut is too loose.
