The great beyond (TBO)

Lessons learned from geriatric engines.

BY MIKE BUSCH

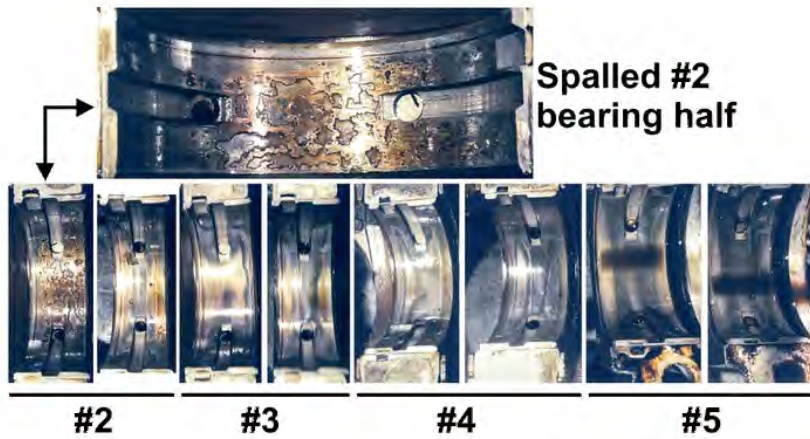
THE ENGINE SHOP tore down Frank's engine and found one half of the number 2 main bearing exhibited serious spalling.

was split, the source of the bronze flakes in the oil filter became obvious—one half of the number 2 main bearing exhibited serious spalling. In fact, so much of the bearing's leaded bronze layer had flaked off (compared to the small amount in the oil filter media) that it was apparent that this deterioration had been going on for some time.

Curiously, the opposing half of the number 2 main bearing was in much better shape, and the remaining main bearings (3, 4, and 5) were in excellent condition. The oil filter contained very little metal.

Frank asked why his regular oil analysis reports had never shown any elevated levels of bearing elements like copper or tin. I explained that this was simply because the oil filter had been doing its job. The flakes coming off the bearing were too large to pass through the filter, so none made it into the sample jars he sent to the lab.
