SAVVY MAINTENANCE / OPINION

(What we have here is a) failure to rotate

Is the conventional wisdom wrong about why exhaust valves burn?

BY MIKE BUSCH

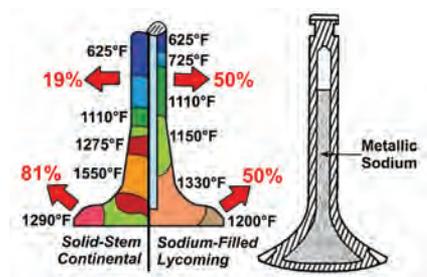
Continental's solid-stem exhaust valves dissipate heat quite differently than Lycoming's sodium-filled valves.

As the graphic indicates, Continental’s solid-stem exhaust valves shed their heat predominantly through contact between the valve head and the valve seat, while heat dissipation of Lycoming sodium-filled valves is split evenly between the head-to-seat interface and the stem-to-guide interface. That’s why a close-tolerance fit between the stem and guide is essential to the survival of Lycoming valves, while Continental valves can usually cope with sloppy-fitting guides so long as the head of the valve makes firm, leak-free contact with the seat throughout its entire 360-degree circumference when the valve is closed (which it is about two-thirds of the time).

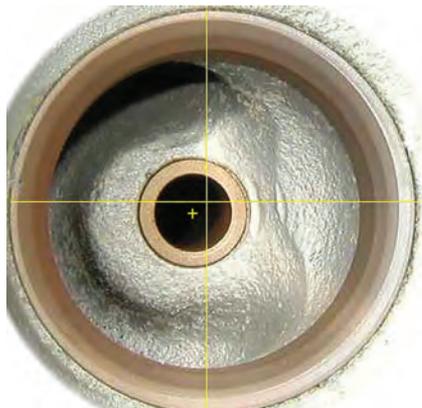
Example of poor concentricity of guide and seat.

Sometimes this is baked into the cake when the cylinder leaves the factory or the engine shop. For example, if the valve guide and valve seat are not perfectly concentric, the valve won’t seal perfectly around its entire 360-degree circumference. There was a period of years during the 1990s when the Continental factory stopped “post-reaming” valve guides after they were installed in the cylinder, and instead was pre-reaming them prior to installation. That turned out to be a really bad idea and resulted in serious concentricity issues. We started seeing large numbers of Continental exhaust valves burned after just 400 to 500 hours in service.

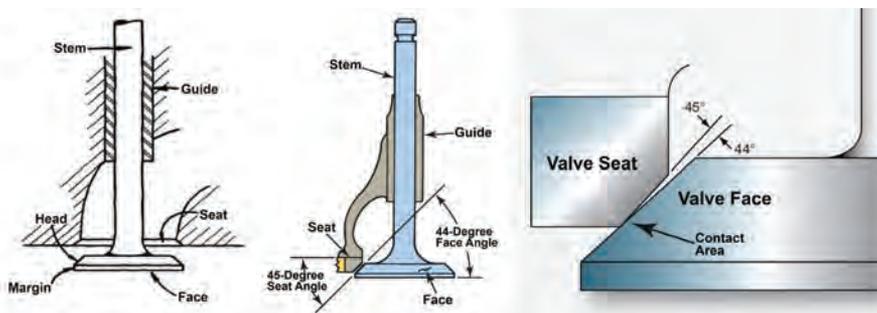
Valve terminology and face/seat angles.

Grinding the valve so it makes proper contact with the seat is harder than it sounds. The overhaul manual calls for the face of the valve to be ground at a slightly different angle than the seat angle in order to provide a narrower contact footprint that will seal better. It turns out that this is tricky business. If the contact area is too wide the valve won't seal well, but if it's too narrow, the heat transfer path from the valve face to the seat is compromised. Valve and seat grinding is as much of an art as a science, and some engine shops do it better than others. Doing it right is particularly important for Continental valves because they are so dependent on face-to-seat heat transfer.

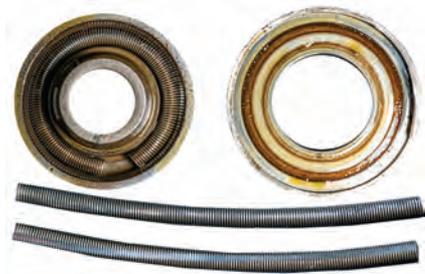
Continental rotocoil disassembled, showing the garter spring (top). Two garter springs, one in good shape, the other badly worn (bottom).

In recent years at Savvy Aviation, we've been finding an increasing number of burned valves caused by failure of the rotator, particularly in Continental engines. The Continental rotocoil contains a garter spring that gets laterally "squished" every time the valve opens, and it's the squishing of the spring that produces the rotation. Unfortunately, this squishing action also causes the spring to wear and eventually it wears enough that the rotocoil stops rotating the valve. Once that happens, it

We've had the feeling that these roto-coil failures are happening a lot more frequently than they used to. There may be a good reason for this. It turns out that Continental's vendor (Federal-Mogul, formerly TRW) made some subtle changes to the rotocoil that seem to have adversely affected its longevity. The older rotocoil (part number 629117) used a larger-diameter garter spring and was held together by a circlip, while the current rotocoil (part number 652112) uses a smaller-diameter garter spring, has no clip, and seems to be failing more quickly, sometimes after as few as 500 hours.

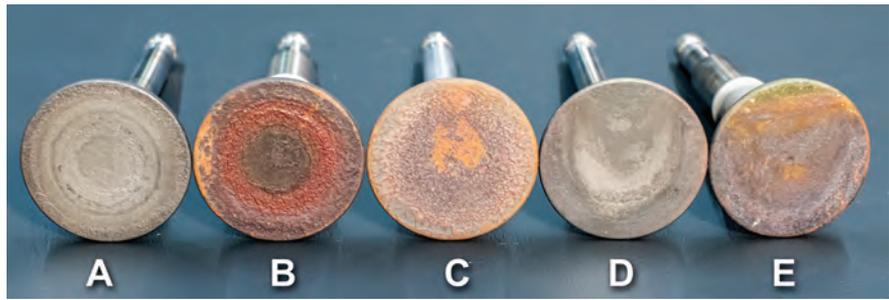
Lineup of five Continental exhaust valves. The left ones look healthy, the right ones don't.

The good news is that it's pretty easy to detect exhaust valves that have stopped rotating simply by inspecting them with a borescope. A valve that is rotating properly will have a symmetrical appearance the way valves A and B in the lineup at top right do. Valve A is cleaner because it has been operated mostly lean of peak (LOP), while valve B has more deposit buildup because it has been operated mostly rich of peak (ROP), but both are symmetrical and healthy-looking. Valve C exhibits subtle signs of asymmetry, probably because its rotocoil has started to fail. Valve D is profoundly asymmetric and definitely not rotating, though it hasn't burned yet and might just need a new rotocoil. Valve E is also not rotating and has started to burn, though there's a good chance the valve could be saved by lapping in place and installing a new rotocoil.

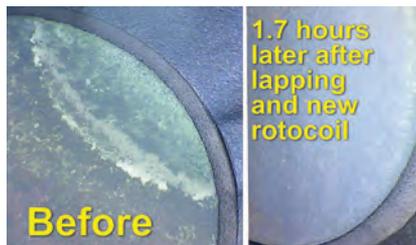
Badly burned exhaust valve, and the same valve 1.7 hours after the valve was lapped in place and the failed rotocoil replaced.

at the striking before-and-after photo I received from Dr. Gary Silver, an A&P/IA who owns, flies, and maintains a Cessna 421 powered by a pair of Continental GTSIO-520s. The photo (above) shows a borescope image of a badly burned number 4 exhaust valve in Silver's left engine, and another image of the same valve only 1.7 hours after Silver lapped it in place and replaced the failed rotocoil. Remarkably, the nasty hot spot has almost completely disappeared.
