# Trust, but Verify

Before you approve any costly or invasive repair to your aircraft, make sure the discrepancy is real

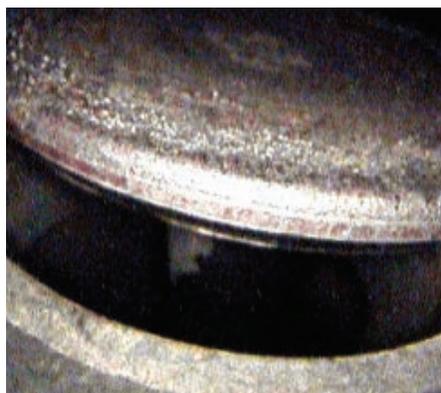
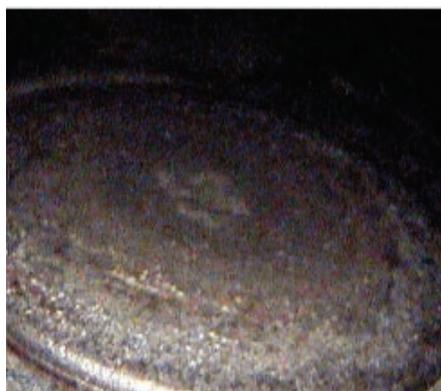
*Figure 1—Borescope inspection of the No. 3 exhaust valve showed the valve condition to be completely normal, with no sign of a hot spot.*

We checked the airplane's downloaded digital engine monitor data and found that the No. 3 EGT appeared normal, with no hint of the slow, rhythmic oscillations characteristic of a burned exhaust valve. We asked the shop to inspect the No. 3 exhaust valve with a borescope, and it reported back that the inspection results were "inconclusive." Further questioning revealed that the exhaust valve had a symmetrical appearance under the borescope (see Figure 1), with none of the lopsided,

green-tinged appearance characteristic of a leaking exhaust valve.

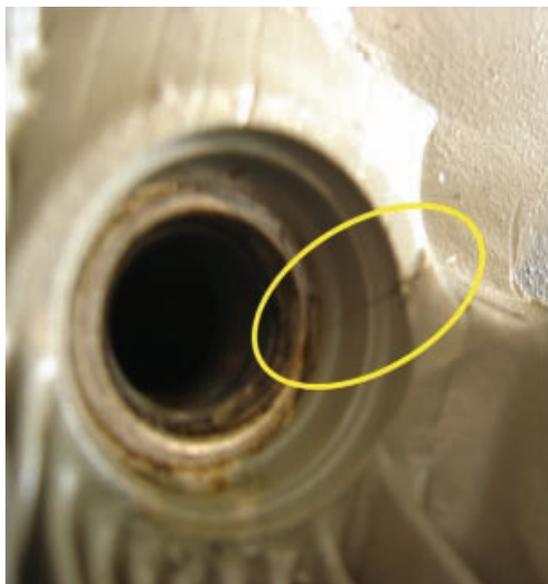
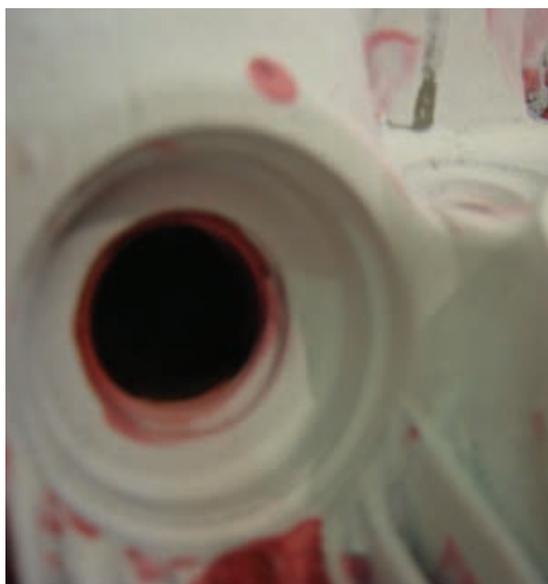
Figure 2—The top photo seems to show a cylinder head crack, but a dye penetrant inspection (bottom photo) reveals that the head is not cracked.

The same week, another client’s airplane was undergoing an annual inspection at another shop. The inspecting IA reported that he found a cracked cylinder head. He sent us a pretty convincing digital photo (see Figure 2, top image) that showed what appeared to be a crack between the

top spark plug hole and the fuel injector nozzle boss. The shop recommended replacing the cylinder and quoted \$3,000 for a new cylinder plus removal and installation labor.

This is the “standard” location for cylinder head cracks to appear on Continental engines. In fact, I’ve lost two cylinders to head cracks in this exact location on my own Continental-powered Cessna 310. On the other hand, our experience is that more than half of the reported cracks in this area turn out not to be cracks at all, but rather superficial cosmetic flaws in the head casting. In fact, unless the crack is clearly blue-stained and leaking fuel, it rarely turns out to be an actual crack.

Therefore, in accordance with our standard operating procedure, we asked the shop to sand the suspected crack area smooth and then perform a dye penetrant

inspection (DPI) of the area. DPI is a quick, low-cost inspection method used to locate surface defects on non-ferrous metals. The DPI kit contains three aerosol cans—cleaner, penetrant, and developer—and the inspection procedure is simple:

1. Spray the surface with aerosol cleaner, and then wipe dry.
2. Spray the surface with aerosol penetrant (typically deep red in color), and allow it to soak into any surface flaws for 10 to 30 minutes.
3. Wipe the surface with a clean cloth moistened with aerosol cleaner to remove all residual red-dyed penetrant from the surface.
4. Spray the surface with aerosol developer powder, and allow it to dry to an even white, powdery layer.

5. Inspect the developer-covered surface. Any cracks will show up clearly as a red line on the white surface, as red-dyed penetrant embedded in the cracks is wicked up out of the crack and absorbed by the white powdery developer.

The shop performed the DPI procedure and sent us a photo of the results. (See Figure 2, bottom image.) The test showed clearly that there was no crack in the cylinder head, and that what appeared to be a crack was a superficial cosmetic flaw. The cylinder remained in service, and the owner found a better use for his \$3,000.

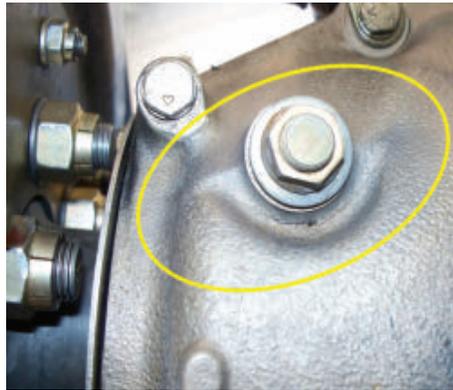
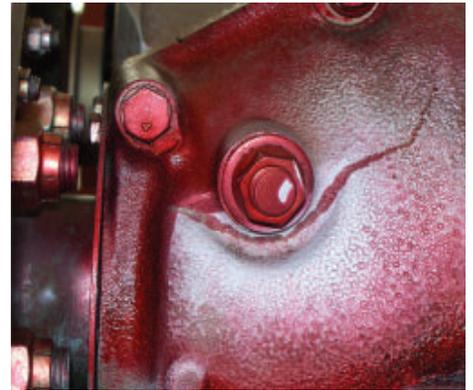
Figure 3—The left photo shows a suspected crack in the nose area of a Continental IO-360 crankcase. A dye penetrant inspection (right photo) clearly confirms that the crack is real, and that its length is sufficient to render the engine unairworthy.

This owner lucked out. We've seen a rash of crankcase nose cracks in Continental IO-360 engines. Figure 3 shows the crankcase of another client who wasn't so lucky. Note how the crack is quite subtle and would have been easy to miss, but the DPI makes it really obvious.
