COMMENTARY / SAVVY AVIATOR

# Separation Anxiety

Can we prevent these catastrophic head-to-barrel separations?

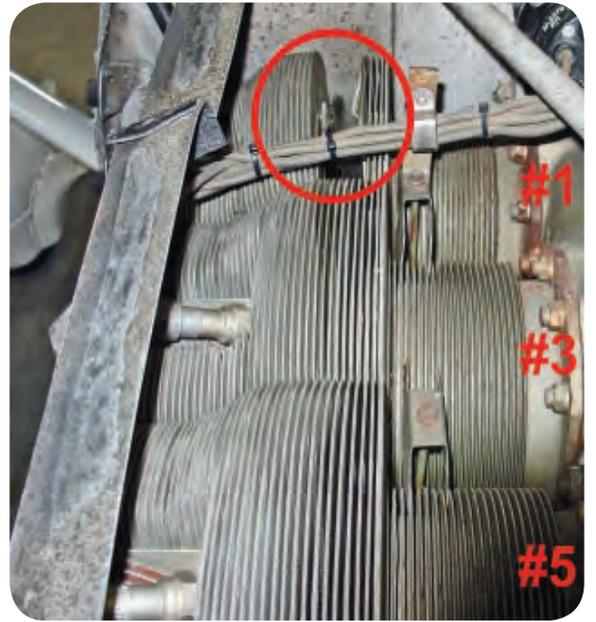
Figure 1—The No. 1 cylinder head on this TCM O-470-U engine suffered a catastrophic fatigue failure in flight. The No. 3 cylinder suffered a similar failure about an hour later.

In May 2007—years before I became a columnist for *EAA Sport Aviation*—I wrote an article titled “Double Trouble,” which recounted the misadventures of a Cessna 182 owner who was flying at 6,000 feet through the desolate Dakota Badlands when his 1,600-hour Continental O-470-U engine suffered a catastrophic head-to-barrel separation of the No. 1 cylinder (see Figure 1). He was able to turn back and fly 20 nautical miles on five cylinders to put the airplane on the ground at Dickinson, North Dakota (KDIK), after losing about one-third of his engine oil.

The Skylane owner did a 20-minute test flight with the new cylinder, followed by an inspection and leak check, and continued his trip—or so he thought. About 40 miles after takeoff, the same thing happened again. This time it was the No. 3 cylinder that blew its top. The owner made another emergency landing, this time at an unattended airstrip in Beach, North Dakota. He'd had enough, and decided to replace the engine.

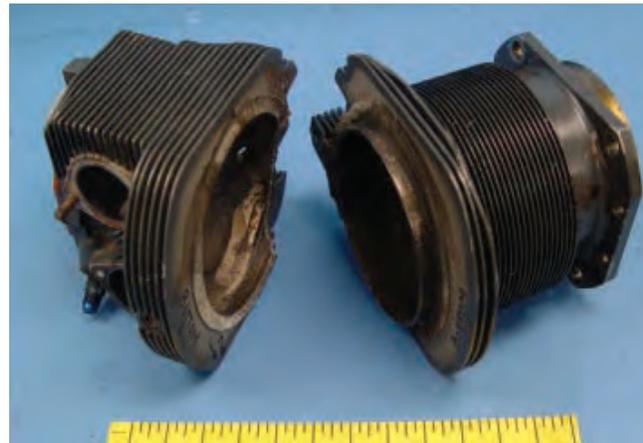
Figure 2—Head-to-barrel separations are not limited to Continental engines. Here's a Lycoming cylinder that lost its head.

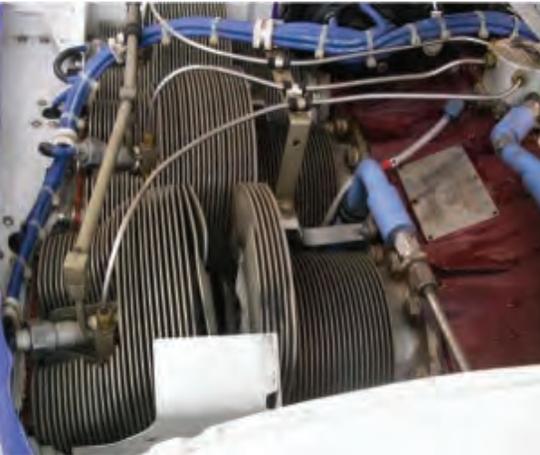
Figure 3—Head-to-barrel separation of the No. 5 cylinder on a Continental TS10-520 engine.

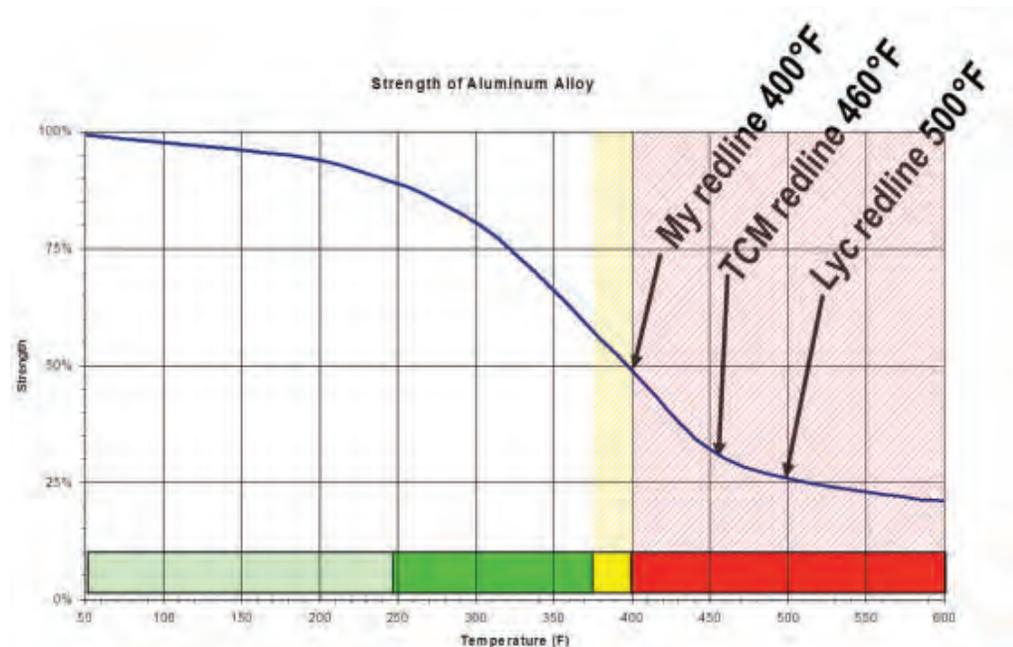
Figure 4—At 400°F, the head casting loses half of its strength; by 500°F, it loses three-quarters of its strength.

I've long been convinced that the answer to cylinder head longevity lies in keeping the heads cool. The strength of aluminum alloys drops sharply as temperature increases (see Figure 4). At 400°F, the head casting loses half of its strength, and by 500°F, it loses three-quarters of its strength. That's why I'm obsessive about keeping my CHTs well-controlled. I always try to keep all CHTs at

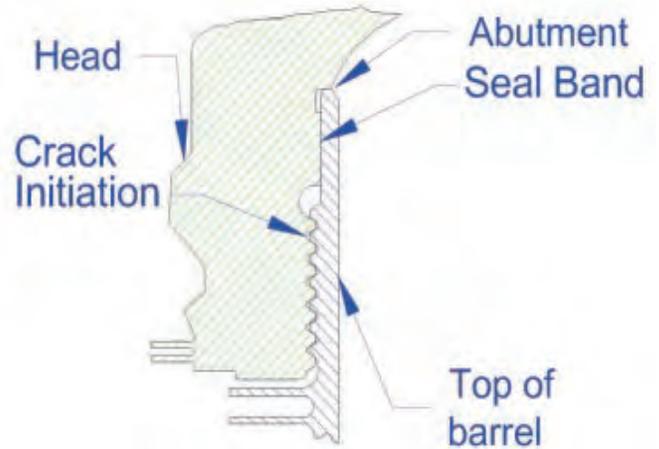
Figure 5—Continental cylinder head-to-barrel junction. The strength lies in the interference fit of the non-threaded seal band. If the seal band loses its grip, crack initiation occurs at the topmost thread.

The head-to-barrel junction is a threaded interface, with internal threads machined into the head, mated to external threads machined onto the barrel. During manufacture, the head casting is heated to about 650°F while the barrel is chilled. The hot

head and the cool barrel are then quickly screwed together until the top of the barrel bottoms out against the abutment surface of the head casting. As the temperatures of the head and barrel equalize, the head shrinks and the barrel expands to create an “interference fit” that locks the two together permanently (see Figure 5).

I'd been under the mistaken impression that it was the threads that held the head and the barrel together, but as it turns out, that's incorrect. The real strength of the head-to-barrel junction lies in the non-threaded area above the threads, variously

known as the seal band, friction band, or shrink band. It is primarily the friction of the interference fit in the seal band area that gives the junction its strength. In fact, ECI's current specs provide for a slightly tighter

interference fit at the seal band than at the threads by a few thousandths of an inch, because its testing revealed that this creates a more robust junction.

The tightness of the interference fit is a function not only of manufacturing tolerances, but also of temperature. As the cylinder temperature rises, both the head and barrel expand. But because the coefficient of expansion of aluminum is about twice that of steel, the head expands twice as much as the barrel. Thus, as CHT increases, the interference fit of the head-to-barrel junction loosens. If the CHT becomes high enough, the seal band can start to lose its grip, transferring stress to the threaded portion of the junction. When that happens, the top thread takes the lion's share of the stress, and ultimately a crack will initiate at that location that can grow over time until the junction fails catastrophically.
