It's Baffling

Mike Busch A&P/IA

Engine Cooling: Then and Now...

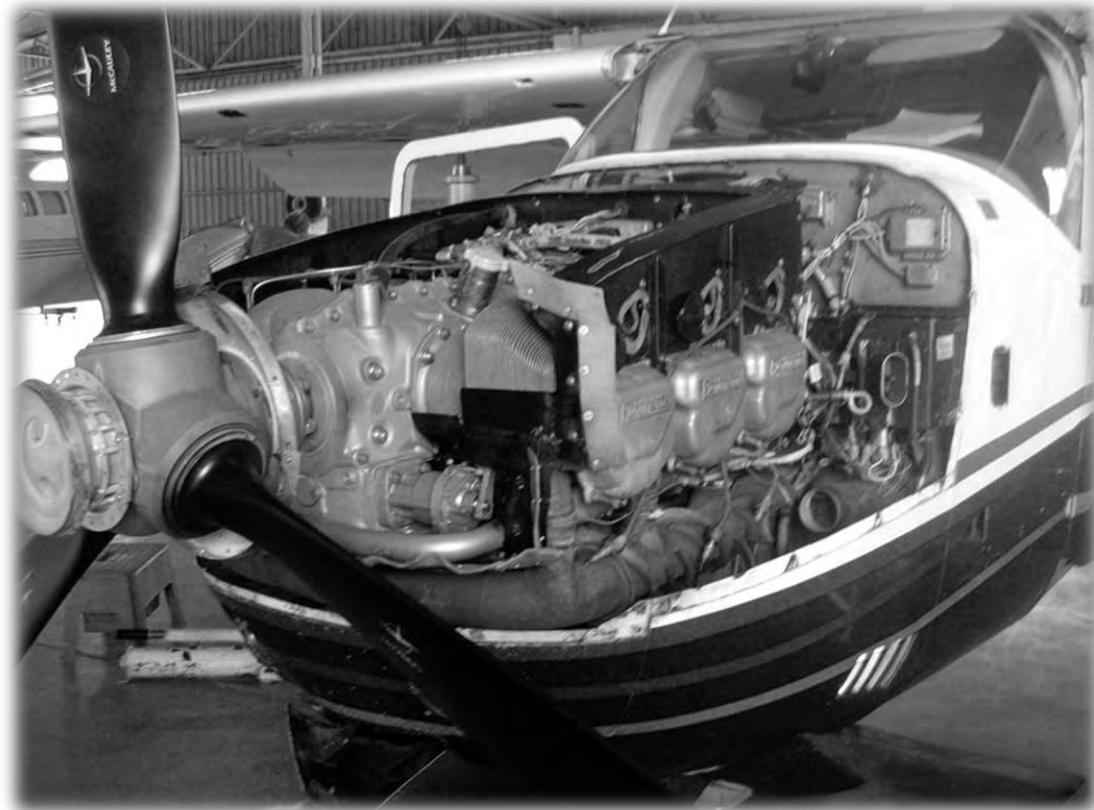
Cessna T210

“The CHTs
for cylinders
#5 and #6
are always
20°F to 30°F
hotter than
the rest...”

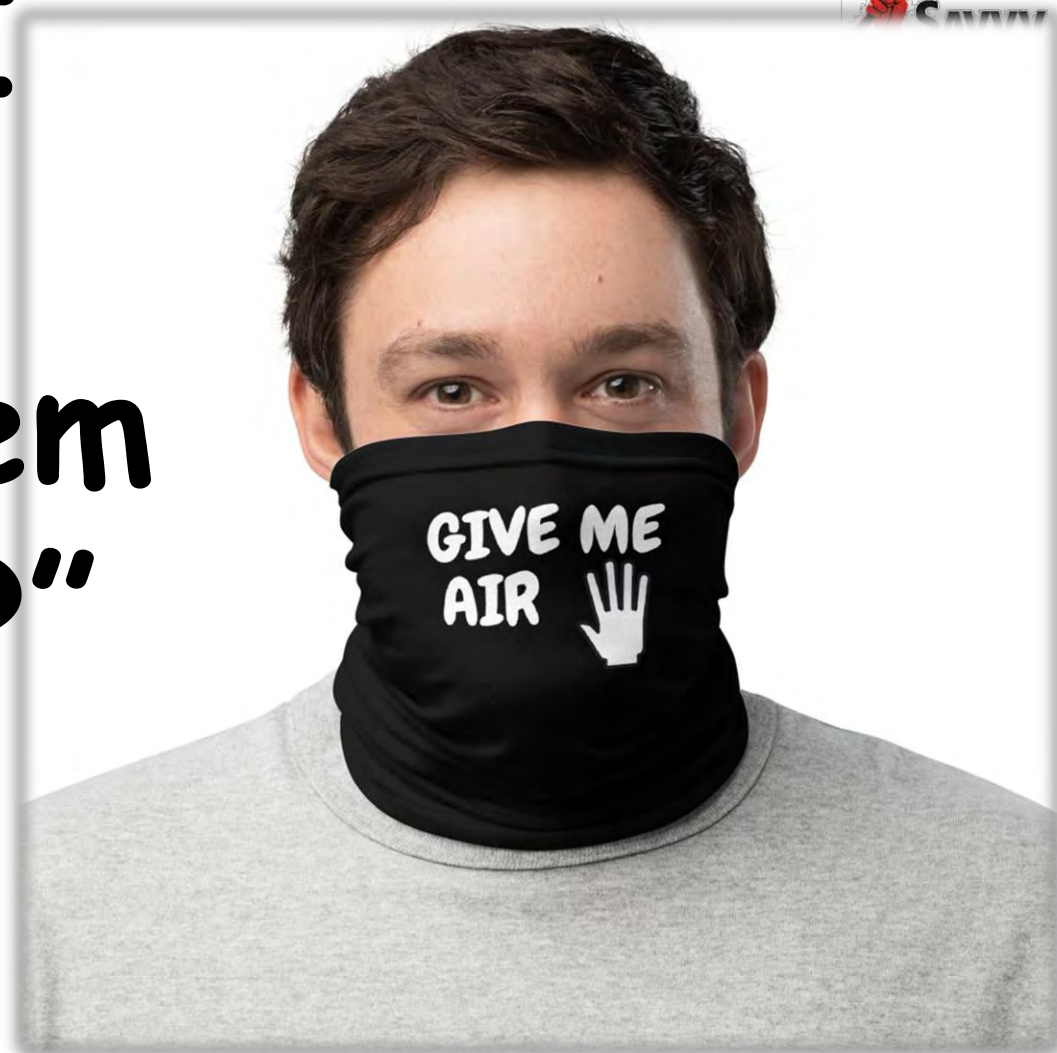
“On cylinder #6, why not cut one or more holes in the white aluminum baffle in front of the cylinder?”

I told the T210 owner that cutting holes in the baffles was definitely NOT a good idea, and that doing so would make his cooling problems worse, not better

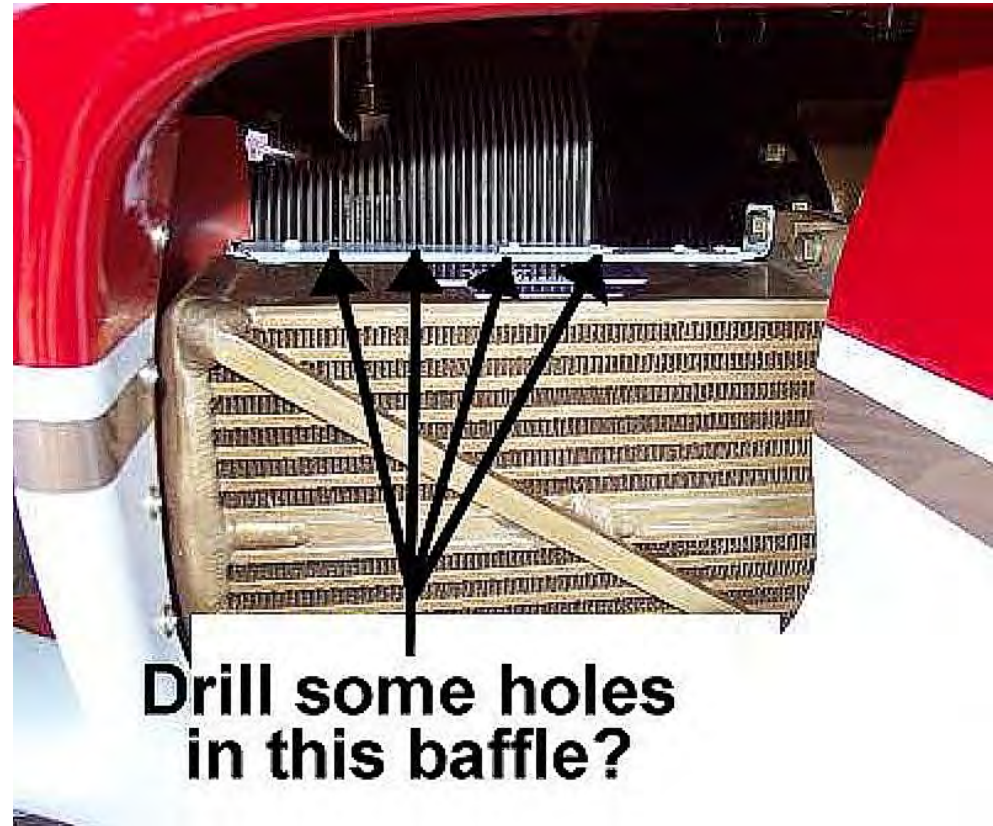
“On cylinder #5, why not drill one or more holes in the horizontal aluminum plate located behind the oil cooler?”

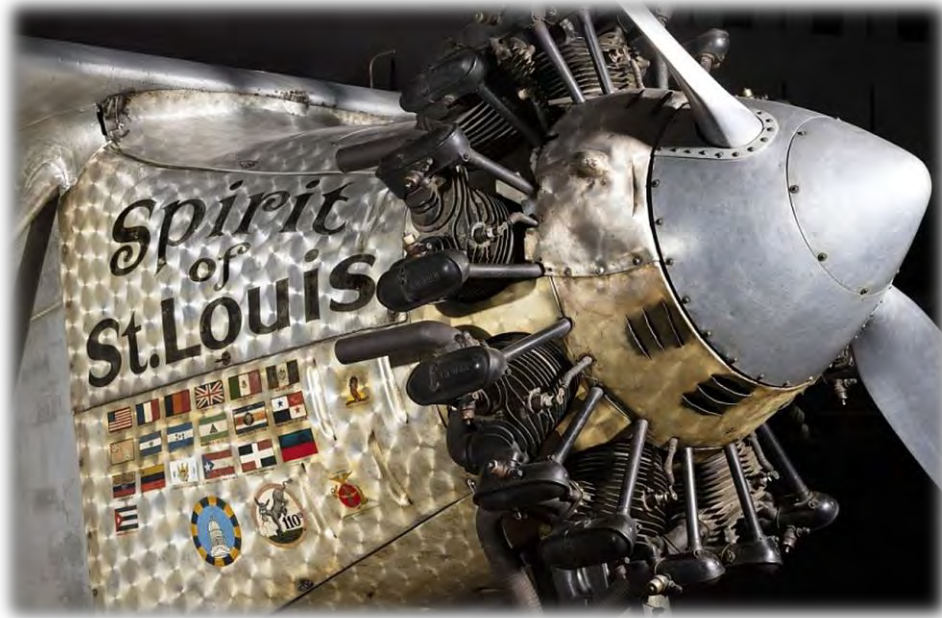
1920s

In the early days, aircraft designers took a simple approach to the problem of cooling aircraft engines...

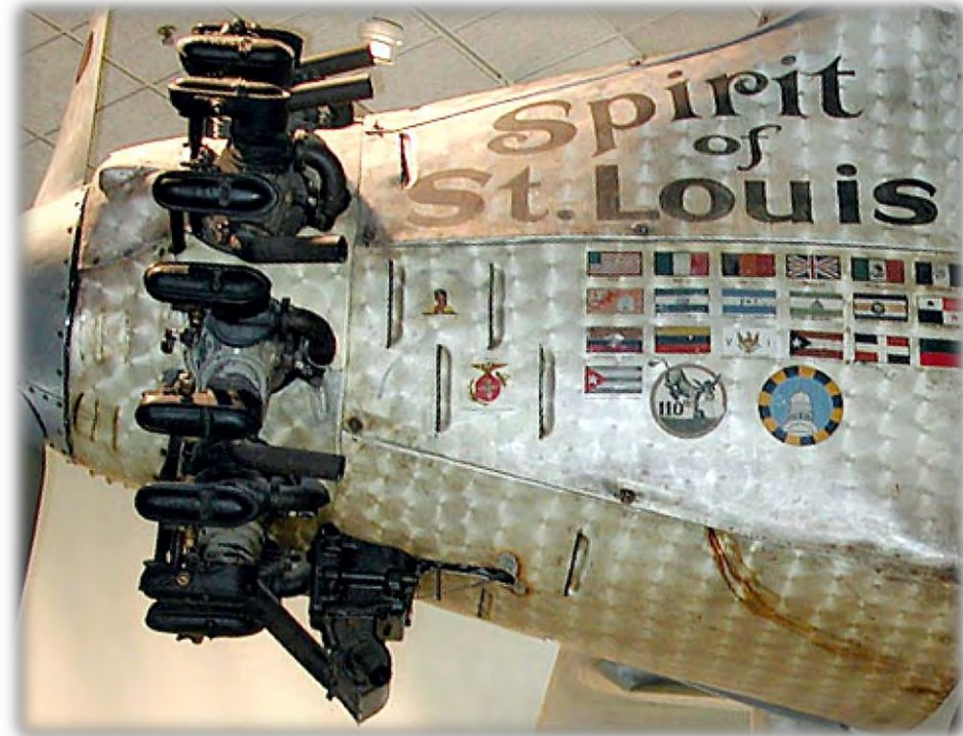
The engines were mounted with their finned cylinders out in the slipstream and cooled by the horizontal flow of ram air

This is known as “velocity cooling” and was adequate for cooling the single-row radial engines of the time

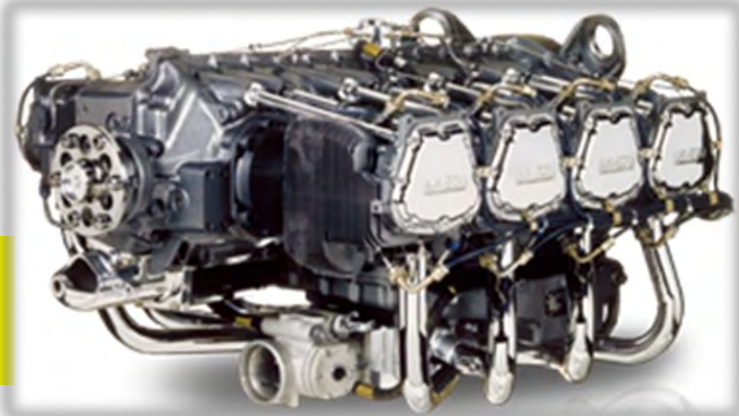
For one thing, **cooling was uneven**—front cylinders got a lot more cooling airflow than rear ones

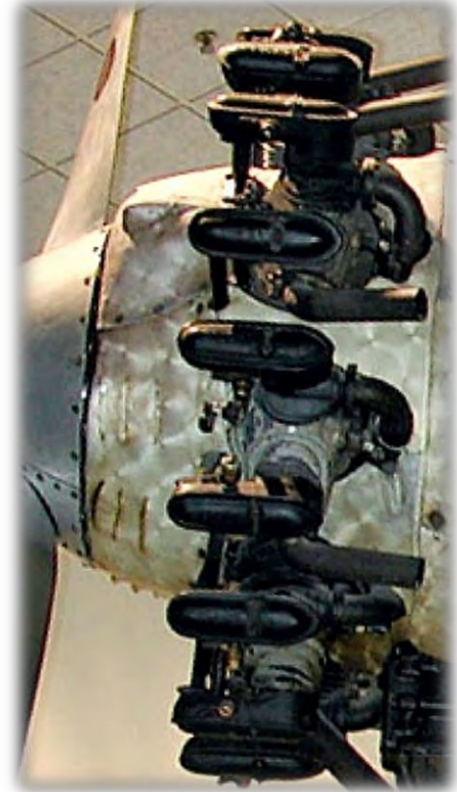
That better system was known as "pressure cooling" and is the method used in all modern piston aircraft

Pressure cooling is accomplished by placing a cowling around the engine and using a system of rigid baffles and flexible baffle seals to produce the volume and pattern of cooling airflow necessary to achieve even cooling with minimum drag

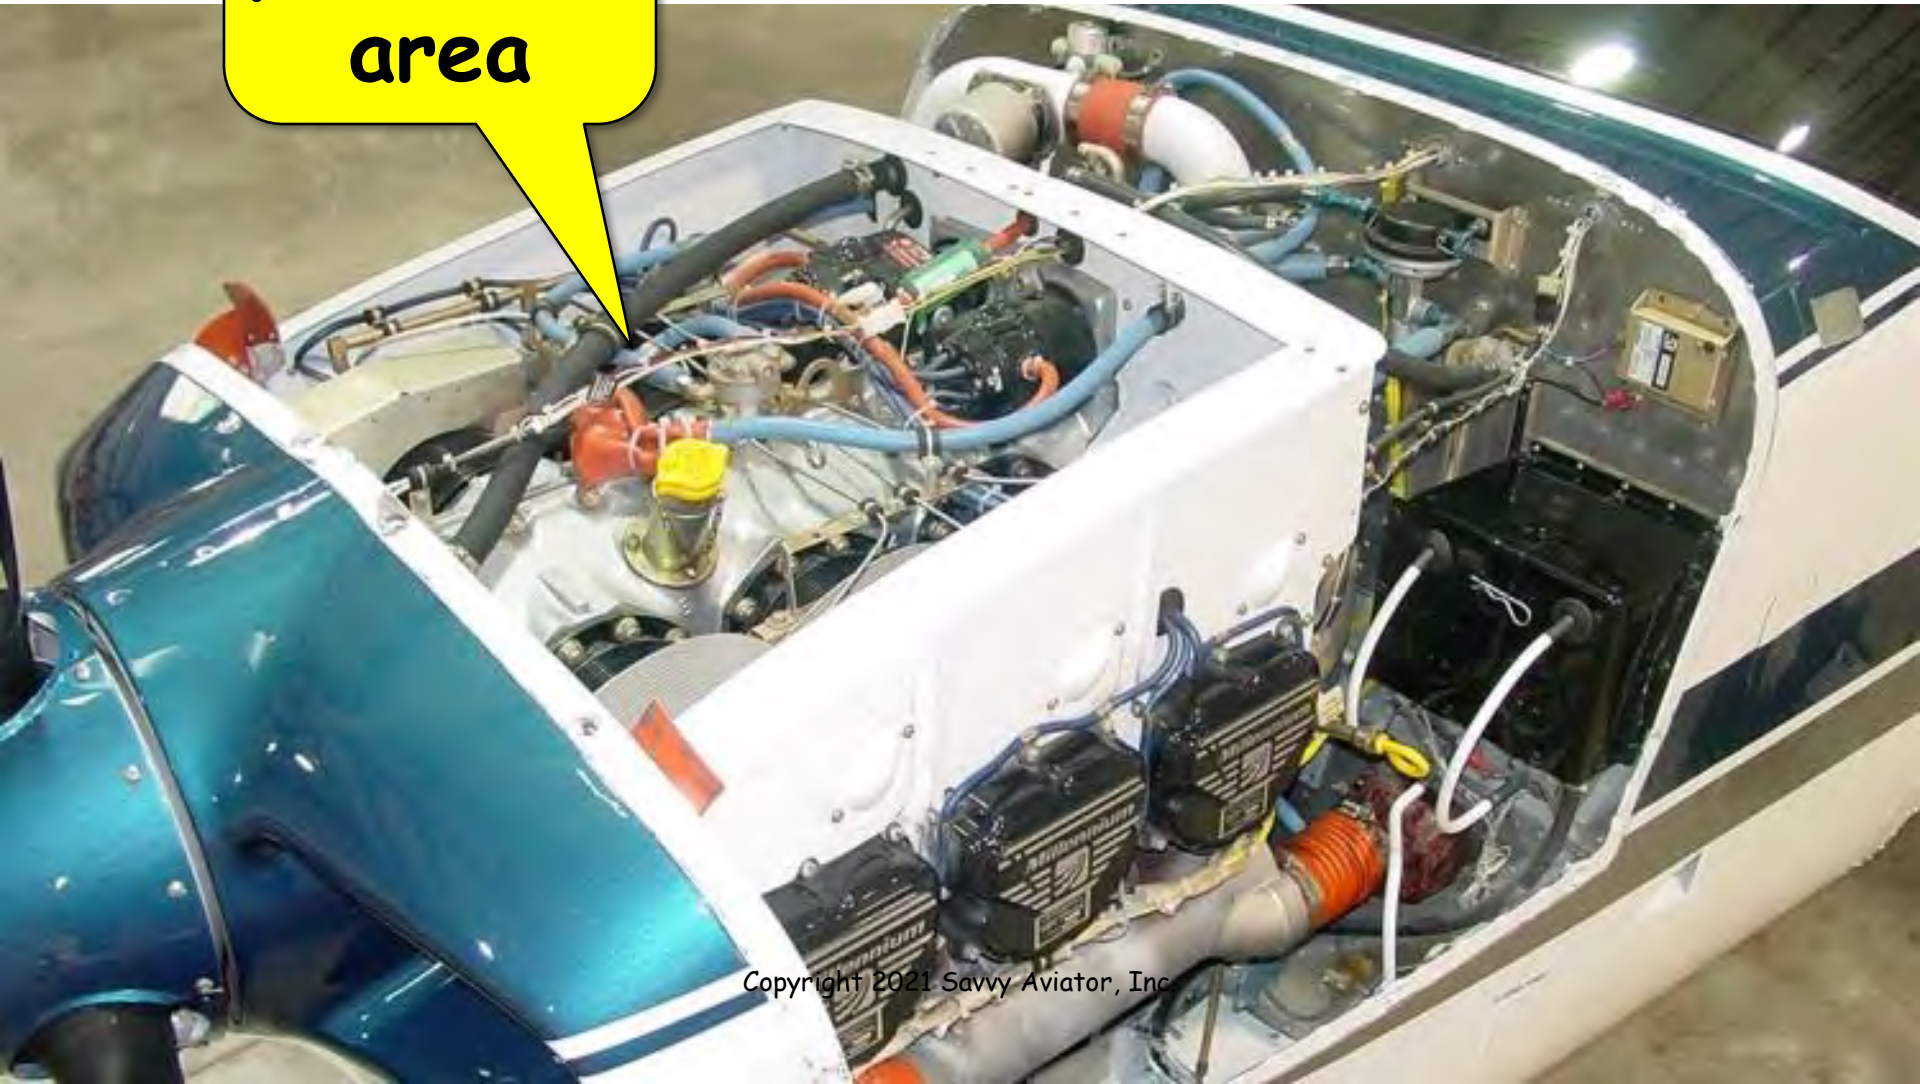
High-
pressure
area

Cowl flaps may be used to modulate the cooling airflow

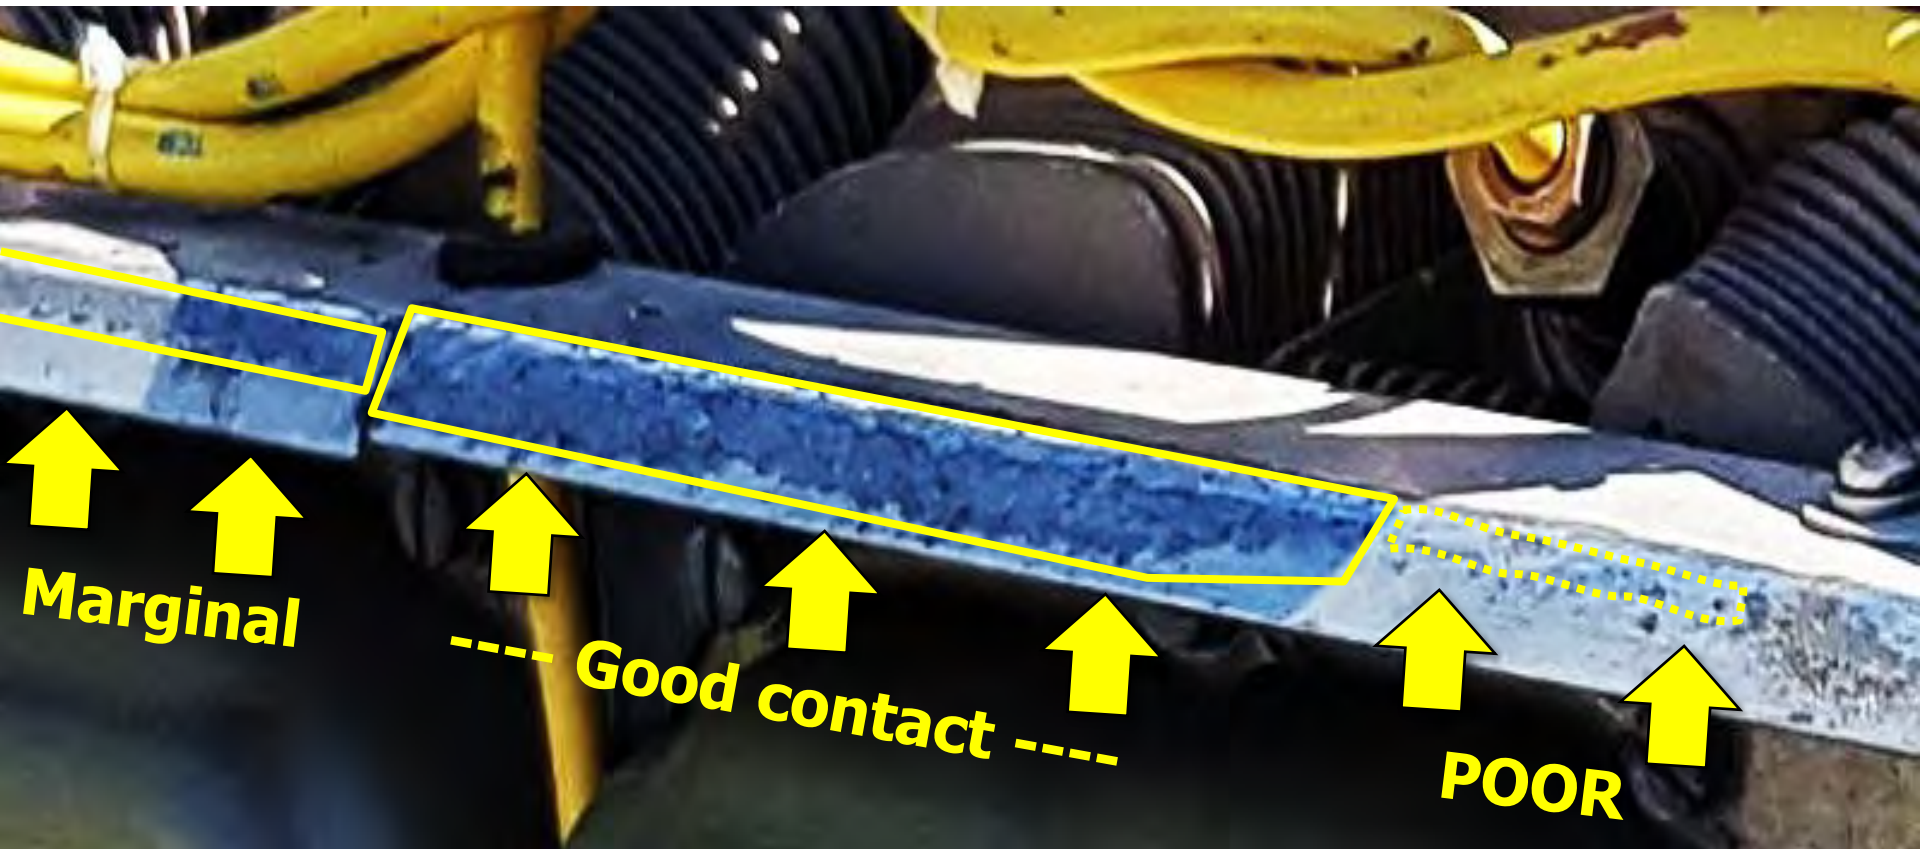
One of the most problematic parts of the cooling system is the flexible baffle seals

These silicone rubber strips are used to seal up the gaps between the rigid sheet metal baffles and the cowling

These flexible seals are necessary because the baffles move around inside the cowling as the engine rocks on its shock mounts

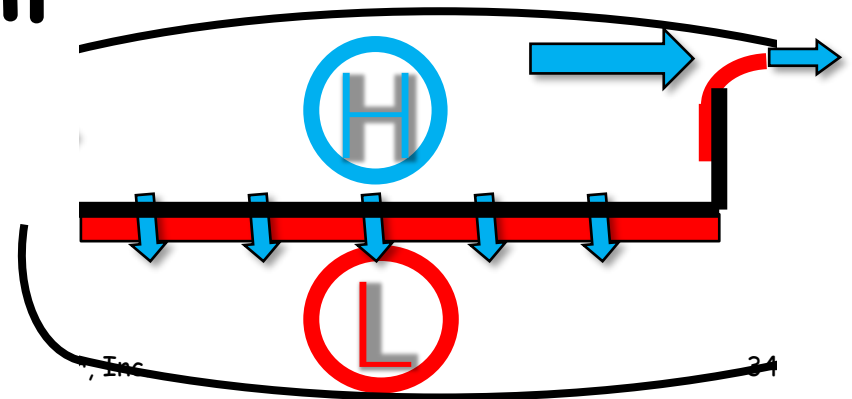
Another common problem is that seals may develop wrinkles or creases when the cowling is installed, preventing them from sealing airtight against the cowling

Inspect for such problems whenever the cowling is removed and replaced

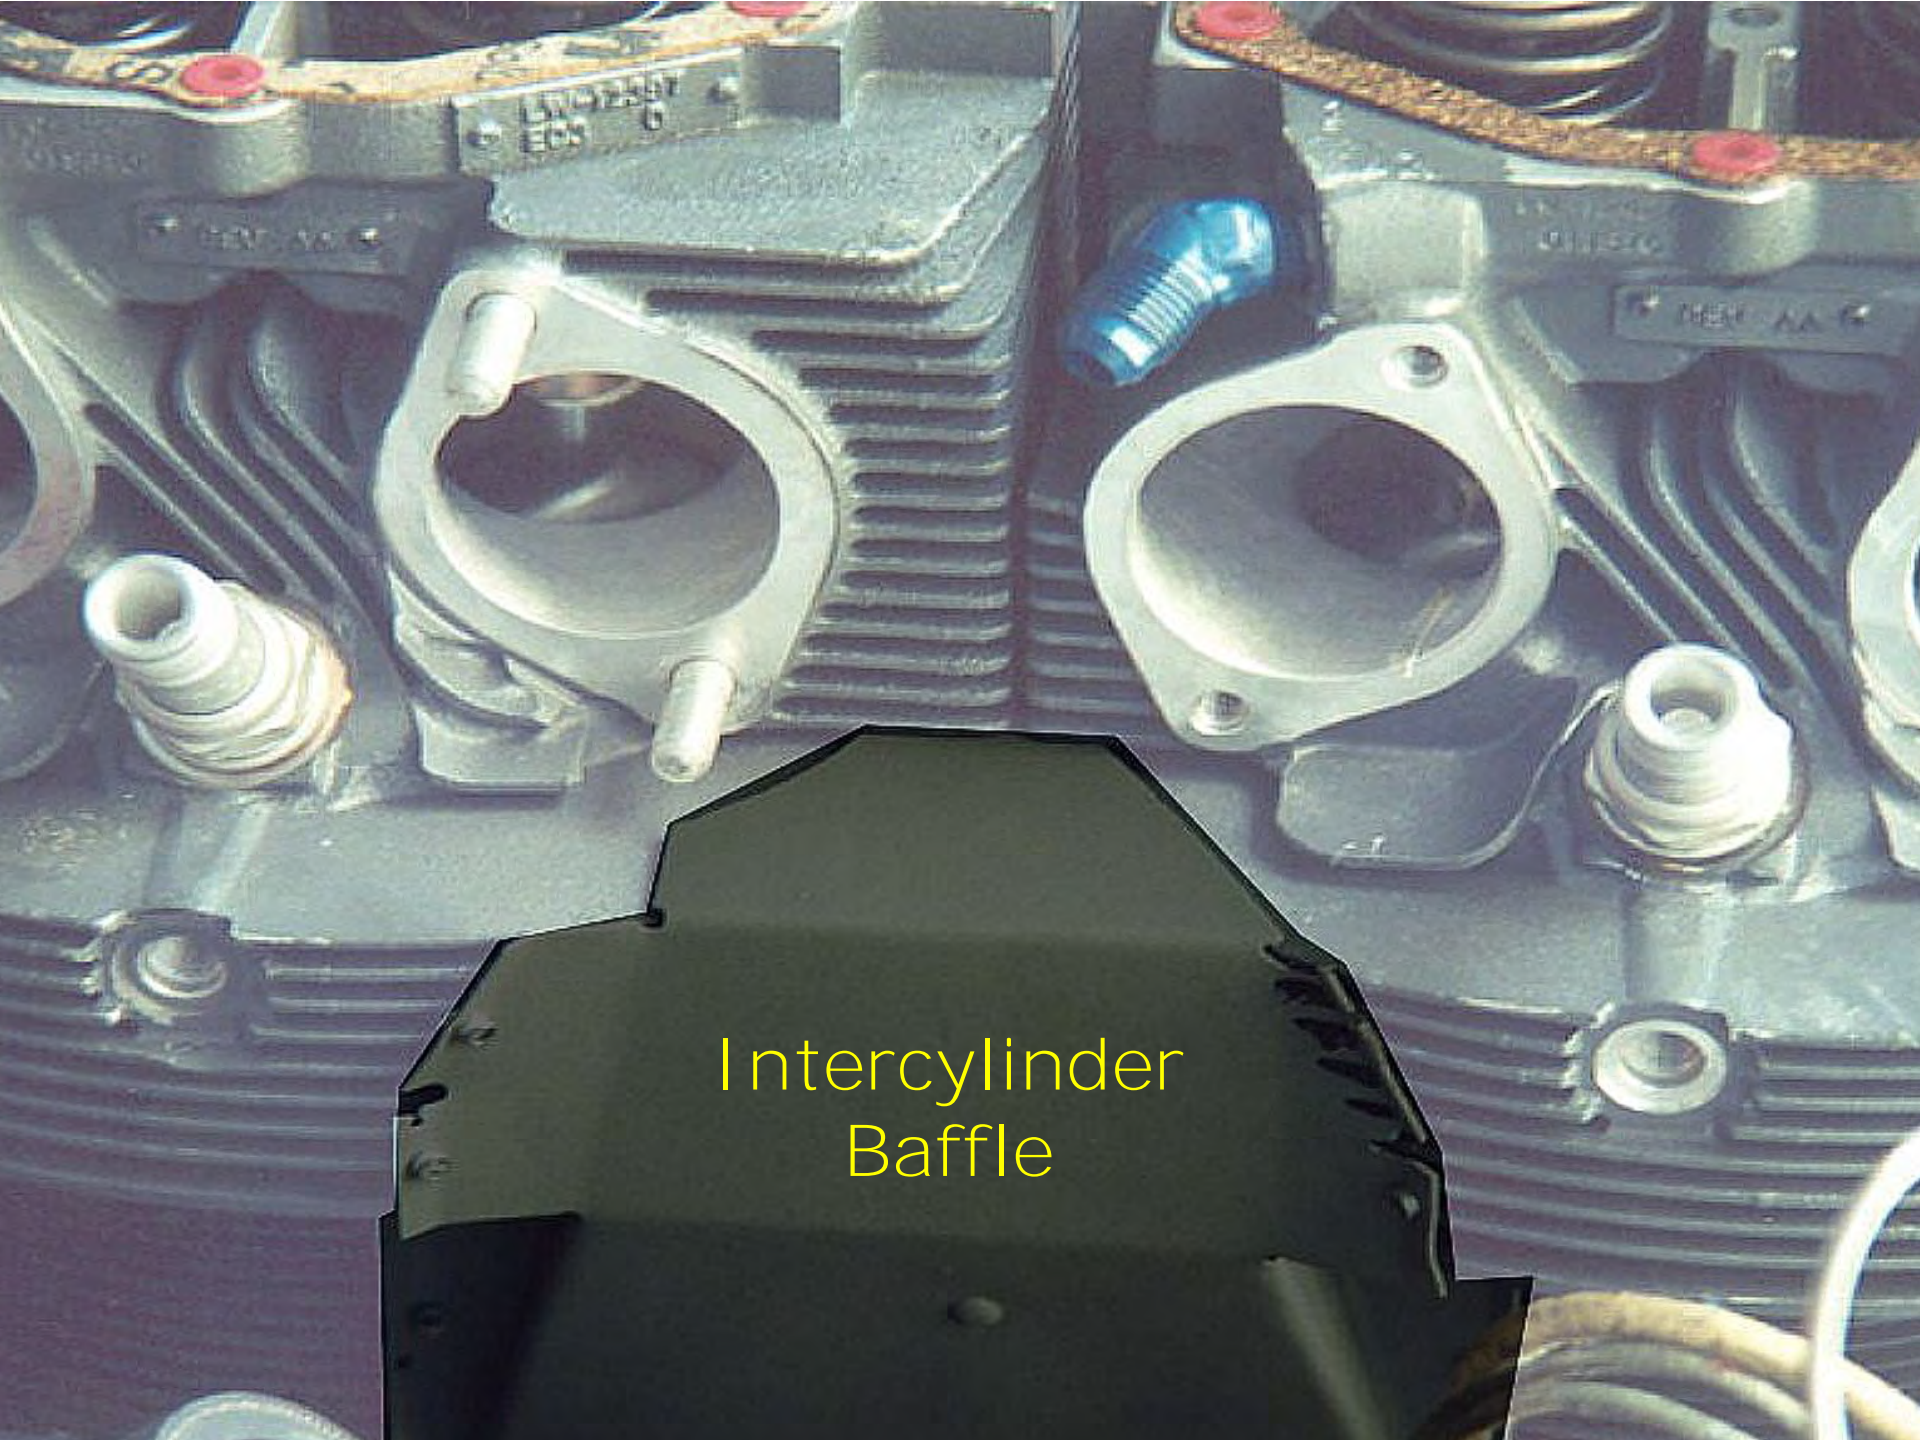
Intercylinder
Baffle

Their purpose is to prevent cooling air from passing through the spaces between adjacent cylinders, and to force the down-flowing cooling air to wrap around and cool the bottom of the cylinders, rather than just cooling the top and side

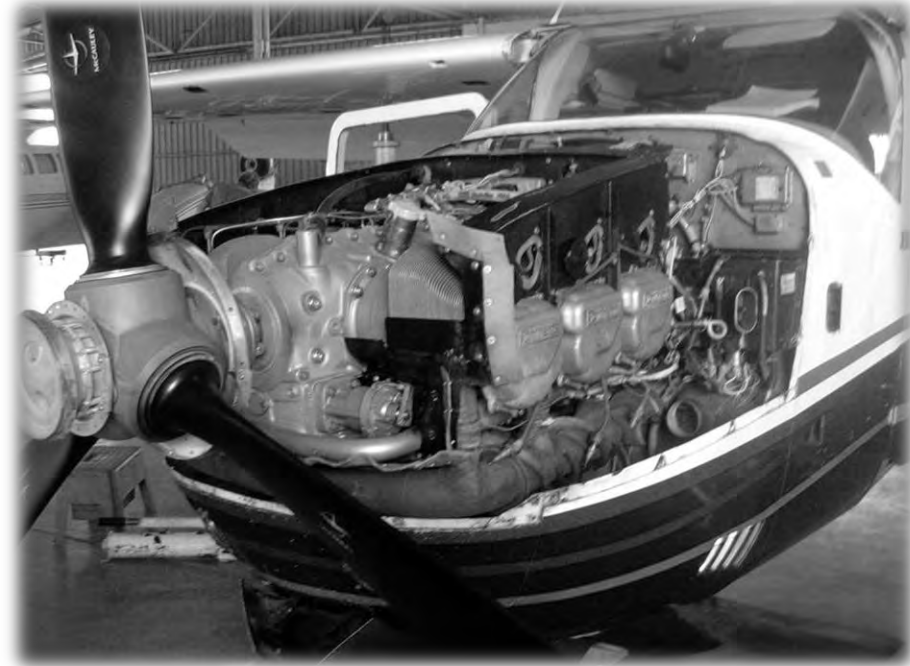
Leak

Studying photos sent by the T210 owner, I was able to identify a dozen leaks in the T210's baffle system—some small, others more serious—that combined accounted for a significant loss of cooling efficiency

With a little trimming of the flexible seal strips plus a few well-placed dabs of high-temp RTV sealant, the owner succeeded in plugging the leaks in short order, and reported that his engine was running noticeably cooler
