# Risky business

Why it's nearly impossible to install a cylinder properly when the engine is on the airplane

BY MIKE BUSCH

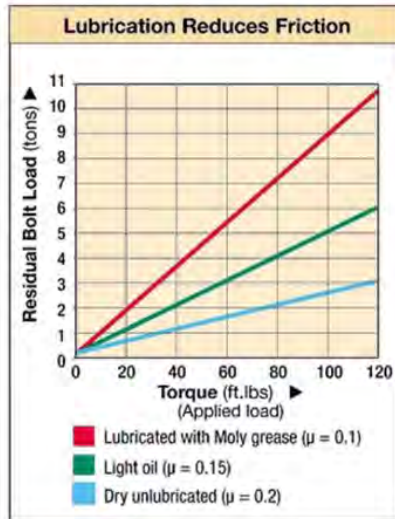
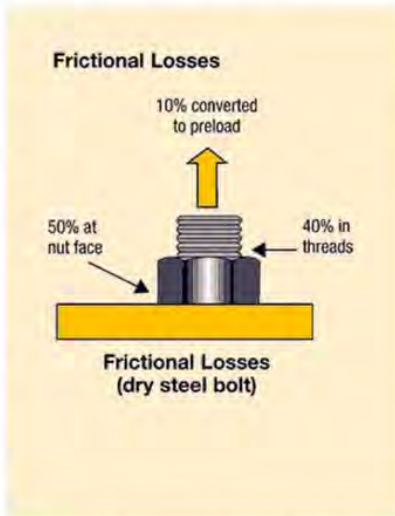
**LUBRICATING FASTENERS** before torquing can have a profound effect on the amount of fastener preload by reducing frictional losses.

**3. The lubricant itself is rather poor.** Fuchs also pointed out that plain 50-weight engine oil (e.g., Aeroshell W100) is a lousy thread lubricant because it lacks synthetics and anti-wear additives that would make it much slipperier. Add this to the likely loss of slippery cad plating from the worn fastener threads, not to mention the possibility of thread damage, and it’s anybody’s guess whether proper torque will result in proper preload.
