# THE MOST UNFORGIVABLE SIN

## RUNNING OUT OF FUEL ONLY HAPPENS TO THE OTHER GUY, RIGHT?

BY MIKE BUSCH

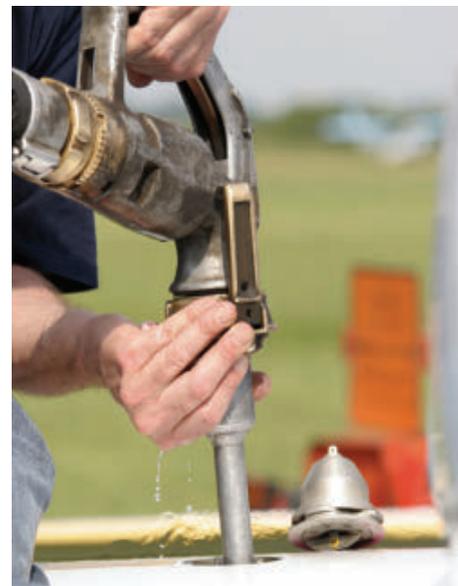
Let’s theorize that when N424E was topped off in Ada, there were only 70 usable gallons of fuel on board (instead of the 78 that Tony believed), because there was 8 gallons worth of entrapped air in the right outboard D-section that couldn’t get out.

As the aircraft warmed under the hot Oklahoma sun, the entrapped air would have expanded, displacing more fuel and forcing it out of the right tank vent onto the ramp. Air expands far more rapidly than fuel, which could account for why fuel was observed venting overboard from the right tank so much more rapidly than from the left tank.

Now let’s theorize that Tony took off from Ada with the left tank selected (as was his habit) and climbed to his cruising altitude in the flight levels. The entrapped air in the problematic right wing would have expanded to more than twice its original volume. (Remember, air pressure drops by half going from sea level to FL180, so volume

Under this scenario, the not-yet-selected right fuel tank would contain not 40 gallons (its assumed capacity) or even 32 gallons (what it probably actually held on the ground), but only 24 gallons. Total usable fuel becomes not 78 gallons or even 70 gallons, but 62 gallons—almost exactly the calculated fuel burn from Ada to 2 miles short of Flagstaff!
