COMMENTARY / SAVVY AVIATOR

# Breakdown!

Bad news away from home

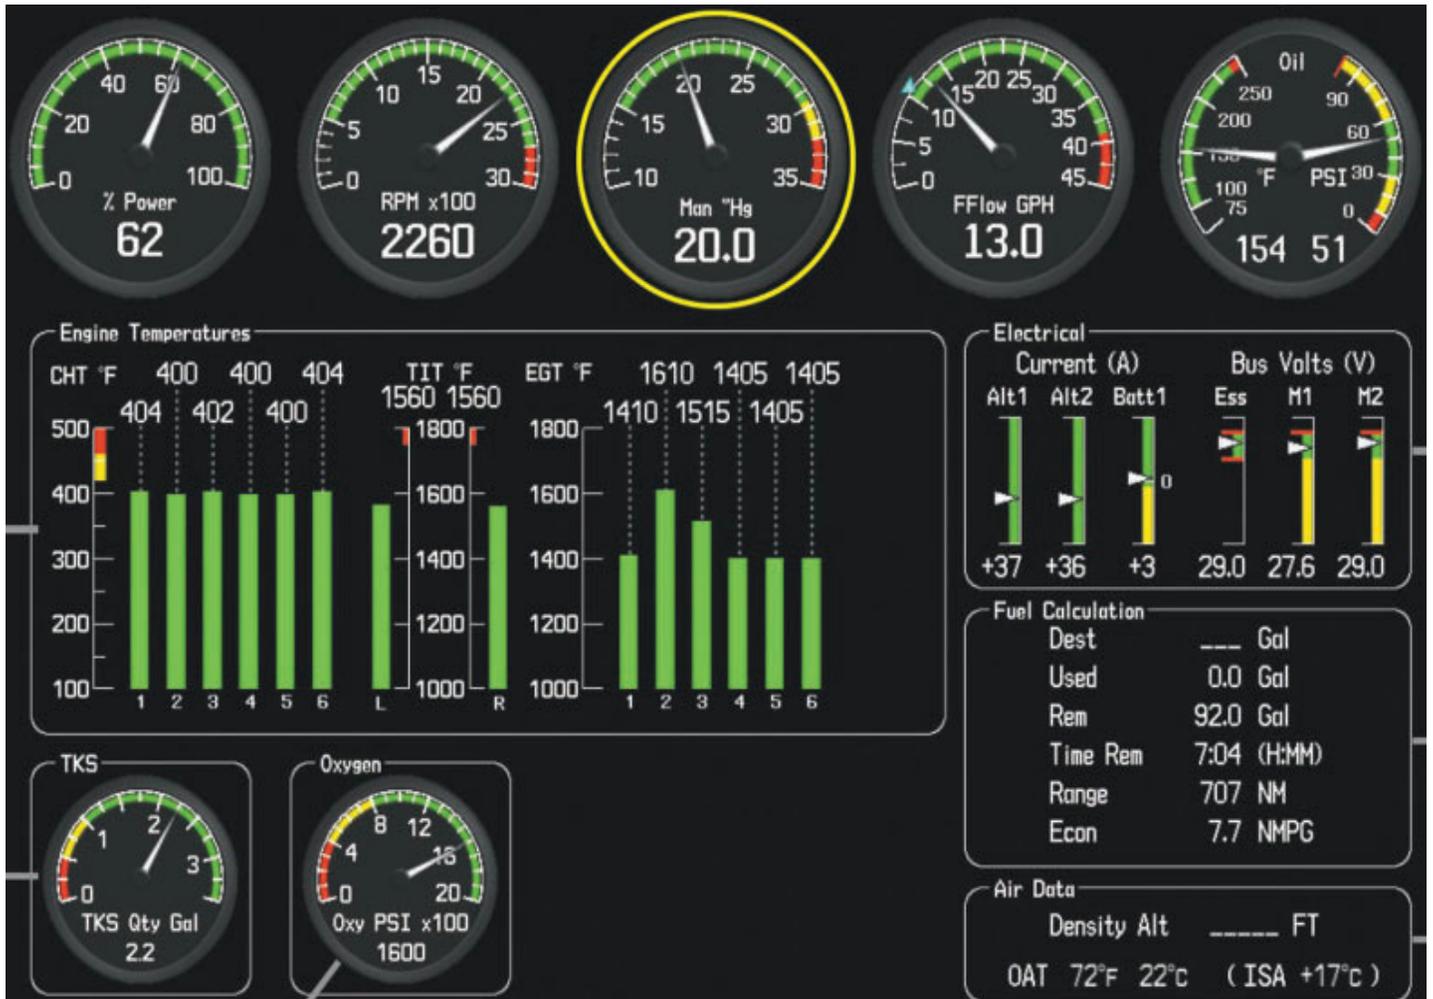
The MFD showed an uncommanded loss of manifold pressure; the turbocharged engine had become normally aspirated.

A bit more than halfway to Kissimmee, however, the pilot sensed a loss of power and airspeed and realized there had been an uncommanded drop in manifold pressure (MP) from the expected 30 inches to something much less. He quickly scanned the information-rich engine data page on his multi-functional display (MFD) and determined that all other engine parameters—CHTs, EGTs, oil pressure and temperature, fuel flow, etc.—were within acceptable limits. It seemed as if the airplane's turbocharged engine had become normally aspirated.

The pilot advised ATC of his predicament and requested a lower altitude. During his descent, MP rose about 1 inch per 1,000 feet, seemingly confirming his "normally aspirated" diagnosis. The aircraft leveled off at the lower cruising altitude. All engine data still looked fine, so the pilot elected to continue to his planned destination and landed without further incident.

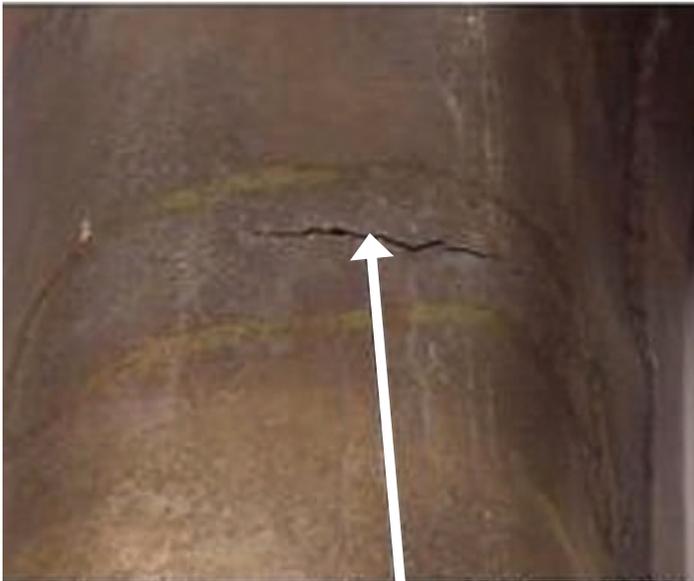
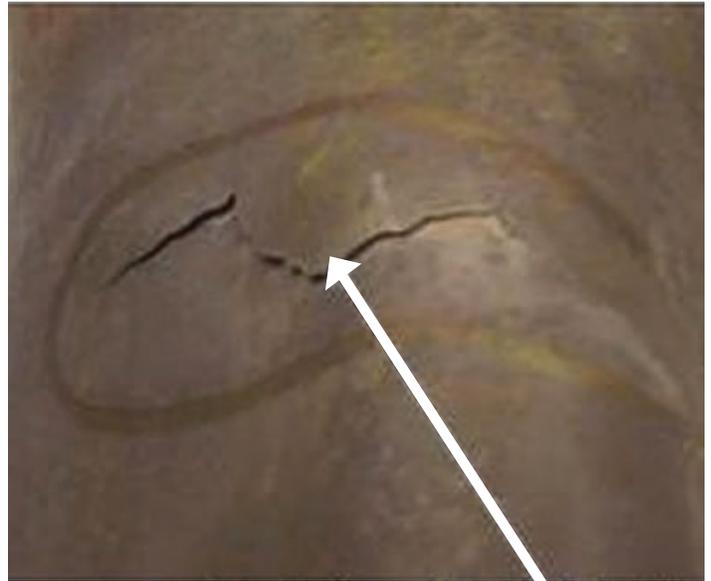
*These exhaust cracks are the sort of thing we were worried about when we advised the Cirrus owner to have a Cirrus-knowledgeable mechanic inspect the engine compartment before further flight.*

like an exhaust leak or flammable fluid leak that might result in an in-flight fire. That was clearly an unacceptable risk. So we advised the owner that while we thought the problem was likely a simple loose hose clamp, we wouldn't feel comfortable about him making the return trip to Arkansas without first having a knowledgeable A&P inspect the engine compartment to make sure that nothing dangerous was going on.
